Feature Form

Site # 44HE388

Curles Field School 6-23-93 44 HE 388

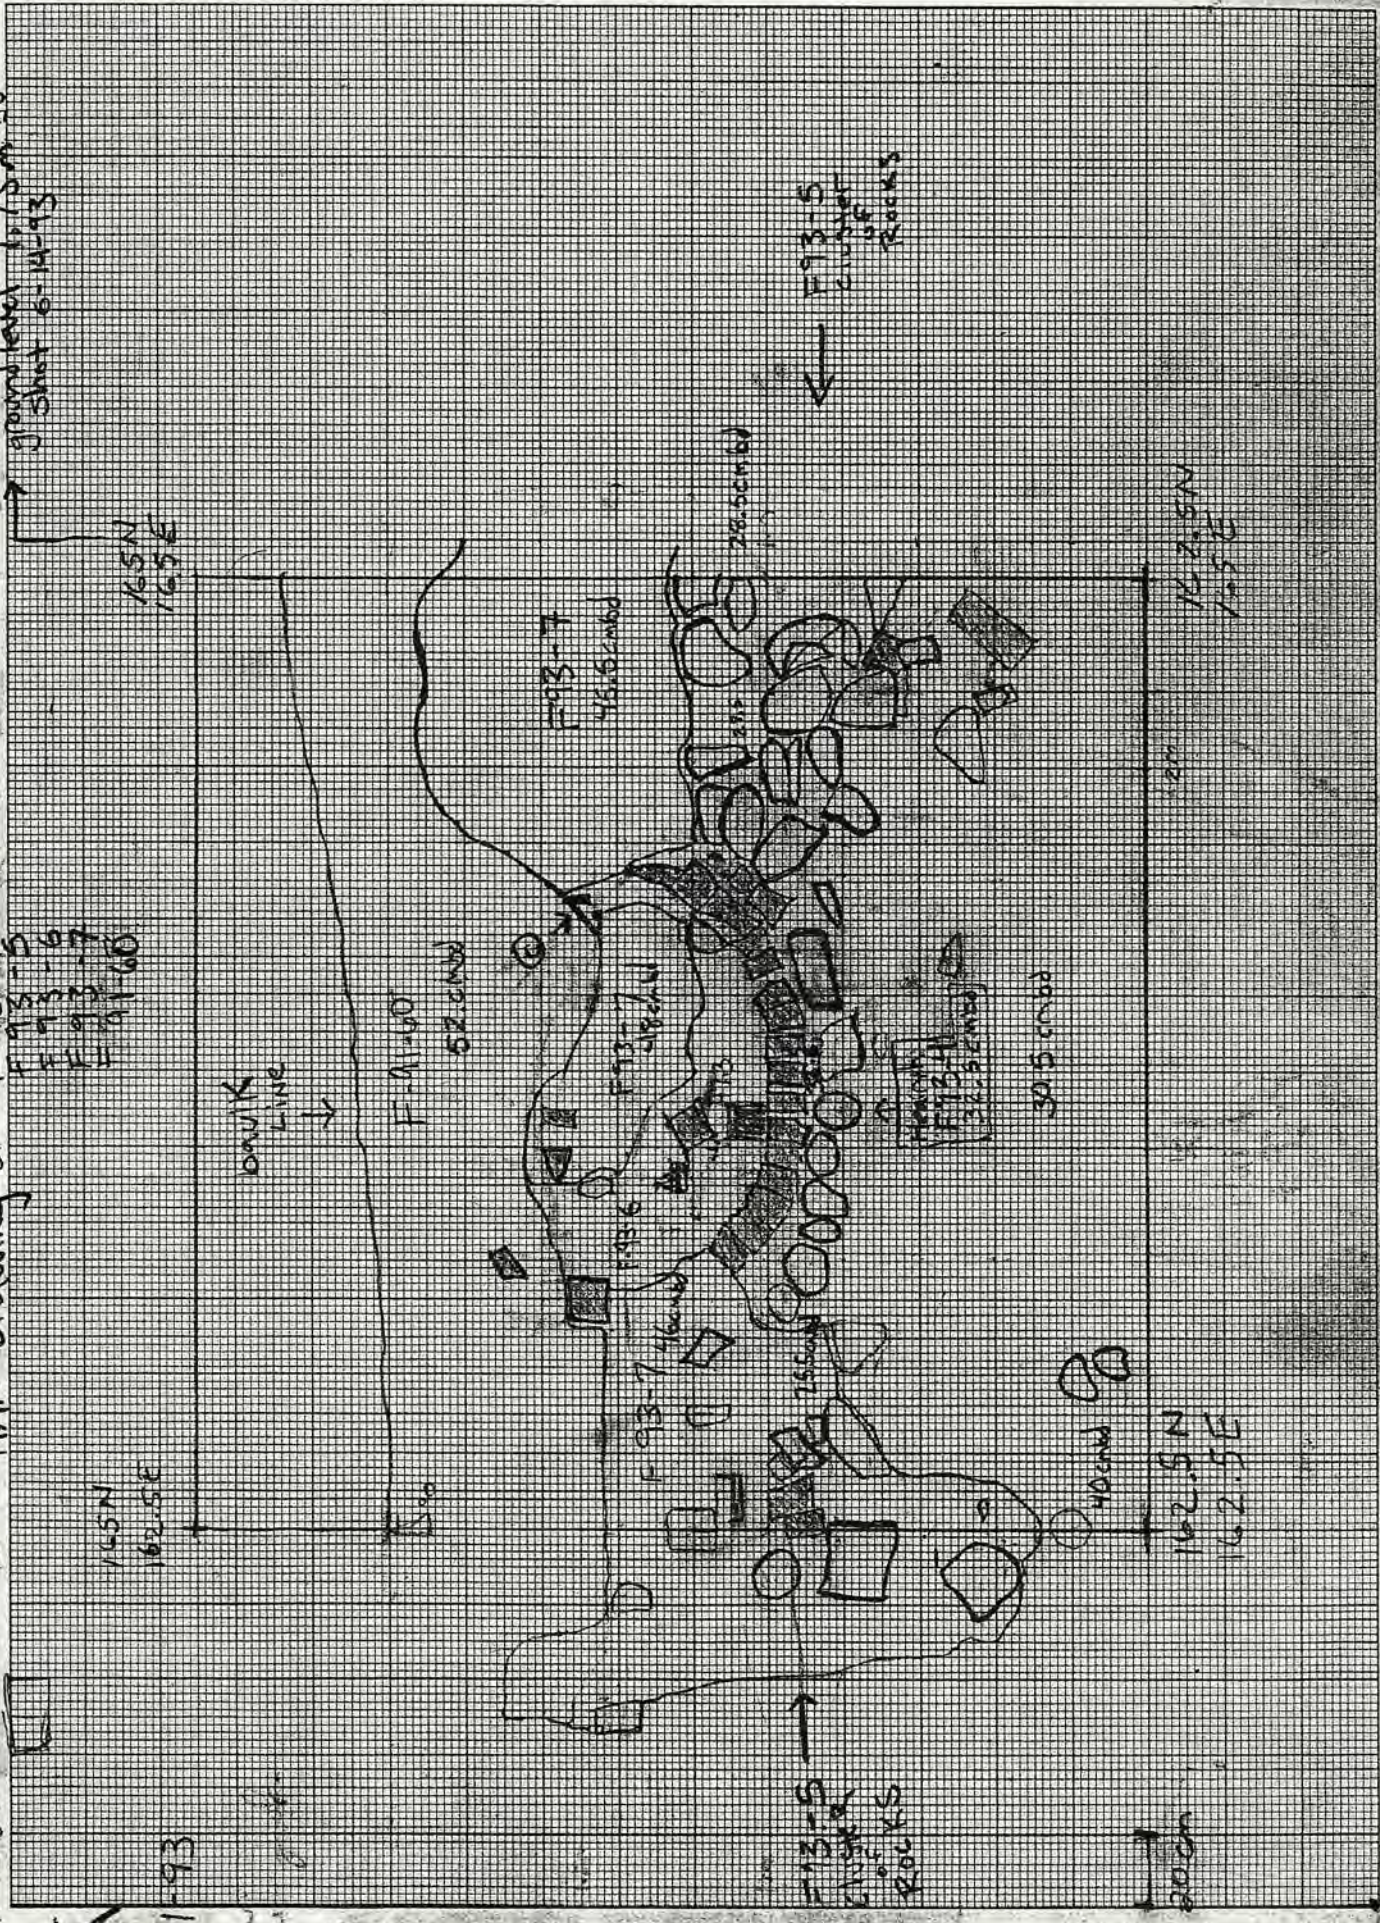
PLAN Drawing of F93-F1

KEY to Plan Drawing of F93-4, F93-5, F93-6, F93-7, F93-8

- - Bricks
- - Rocks - outlined
- F93-4 C shaped hearth feature composed of brick and cobbles
- F93-5 Disarticulated stones surrounding F93-4
- F93-6 Dark brown sandy loam stain adjacent to F93-4
- F93-7 Irregular stains surrounding hearth composed mostly of brick rubble
- F93-8 Irregular brown stains surrounding hearth, mainly reddish with brick charcoal and char.
- ⊙ - charred wood →

(SEE General RECORD FOR Trench 93-3). The bricks making up 'C' in hearth are whole, upright bricks. On the east side of the 'C' there are *two bricks in line running N-S. There are bricks in place (hearth floor) ca. 35mm beneath top of 91-60/91-6/93-7, running North from 'C' and beneath 'C'. The lines of brick run E-W lengthwise and extend ca. 24 to the North from 'C'. The bricks are burned.

17 June 93 Trench extended .77 to the west. 7 more bricks of the 'C' were exposed. The hearth floor continued into this section of trench and may continue under W. wall of trench. The hearth floor is not fully intact, many bricks in mid section are broken or missing

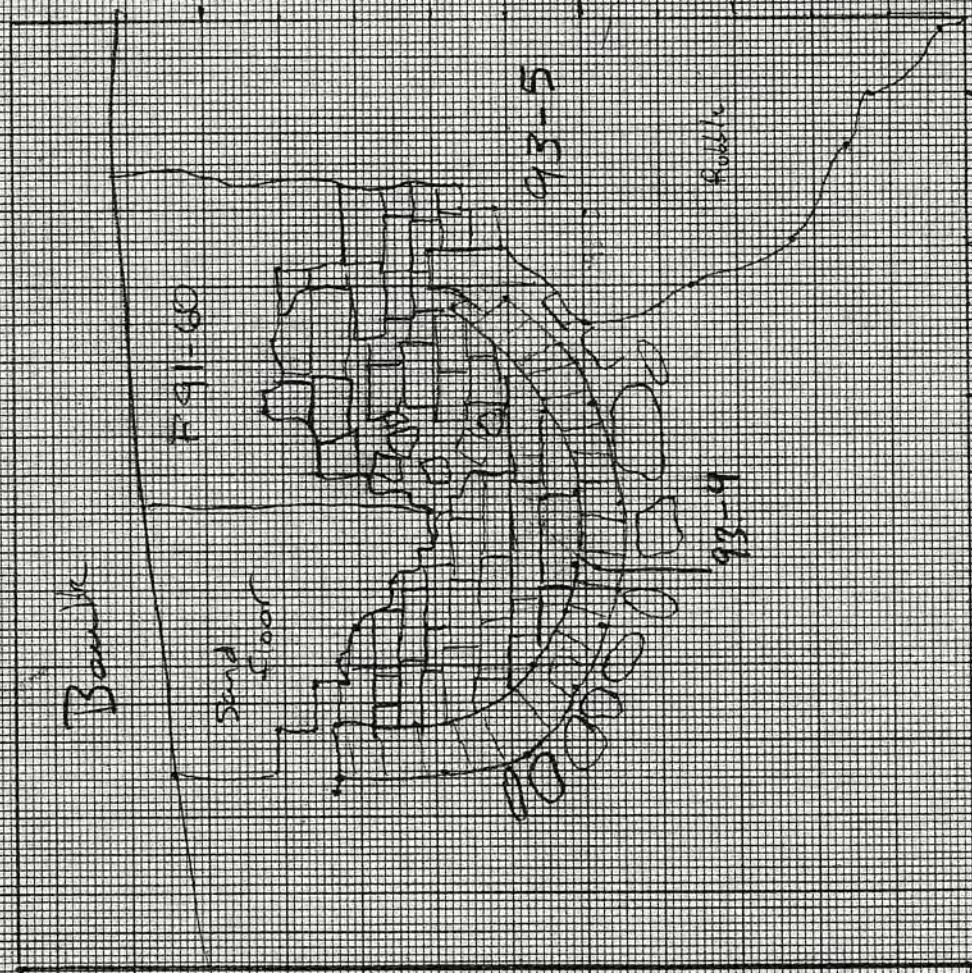
Katherine & Jeff
SW Quad: 162.5N 162.5E (20m)
1mb F 2cm
F 93.4
5
7

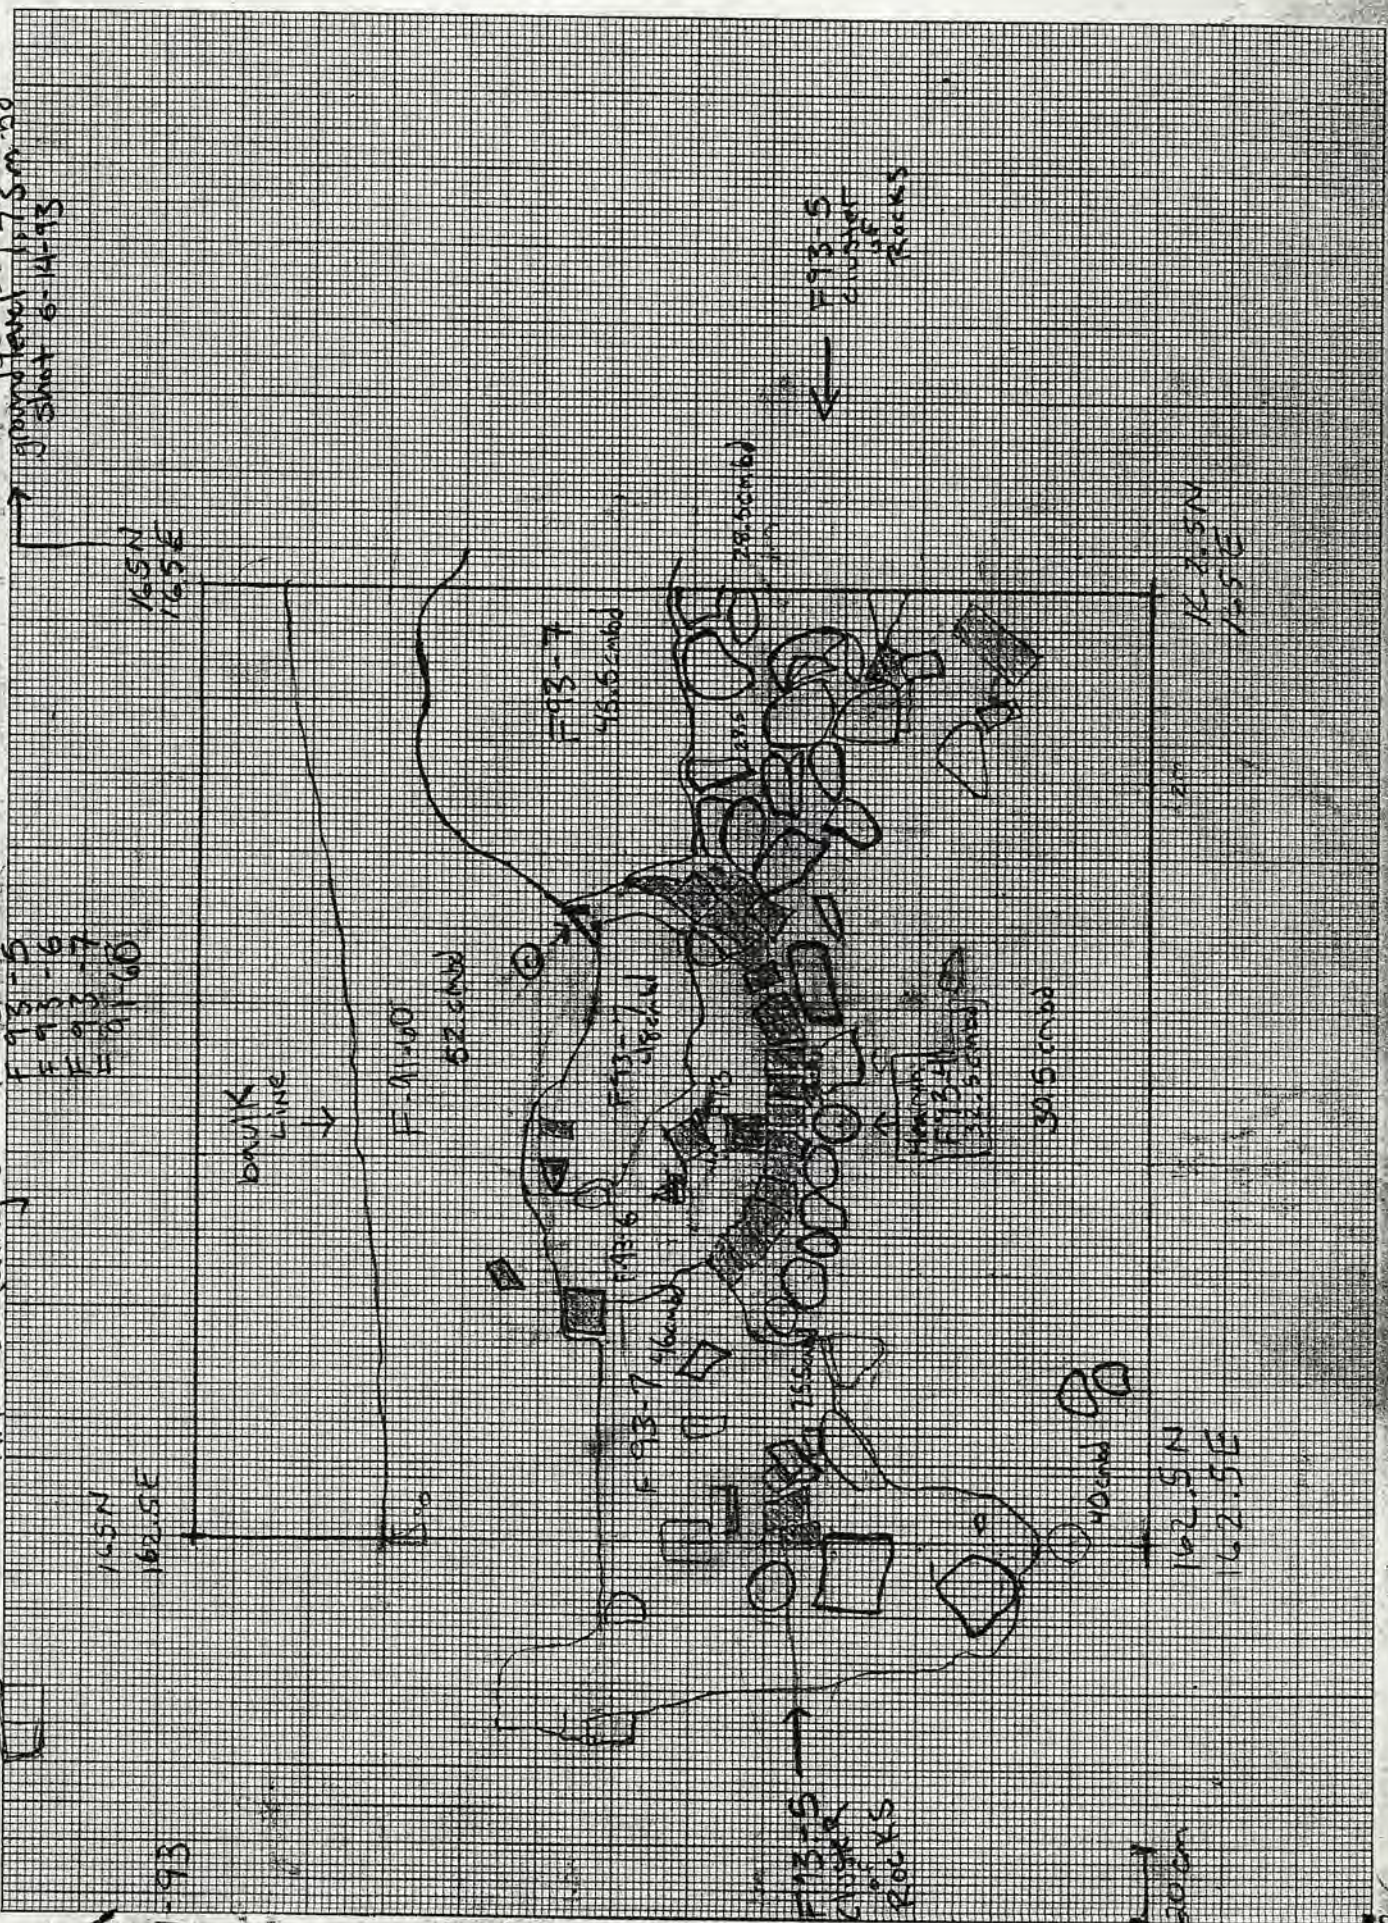
PLAN Drawing of F93-H

KEY to PLAN Drawing of F93-4; F93-5; F93-6; F93-7; F93-8

F93-4 C Shaped hearth feature composed of brick and cobbles

F93-5 Disarticulated stones surrounding F93-4

F93-6 DARK brown sandy loam stain adjacent to F93-4

F93-7 irregular stain surrounding hearth composed mostly of brick rubble

F93-8 irregular brown organic feature surrounding hearth, heavily mottled with brick, charcoal and char.

EU# 8026 Removed large rocks and bricks (appx. 10 cobbles, 7 bricks) from surface of area front ^(part) light brown sandy soil (F# 93-9). Revealed small amounts of same soil underneath (rocks were resting in F# 93-9).

EU# 8074 - Removed cobbles and bricks (some whole, mostly broken) from atop F# 91-63 - a brick and charcoal flecked wash layer; fairly sandy. Some nails and other unidentified metal objects were found adhered (probably corroded to) bricks & cobbles. Some bricks and cobbles also →
Dated Started 6/16/93 Finished 6/16/93

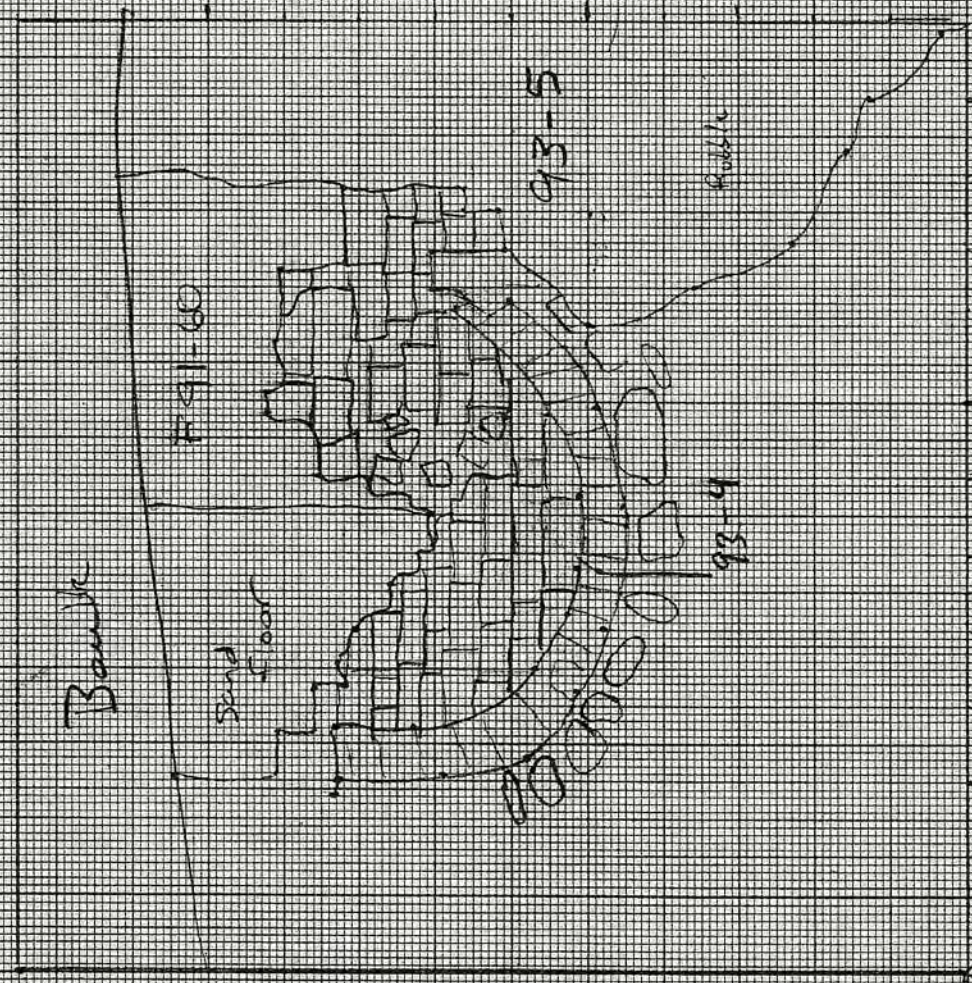
Katherns & Jeff
SW Quad: 162 SW 162 SE
1 mi E 2 mi
F 93-4
5

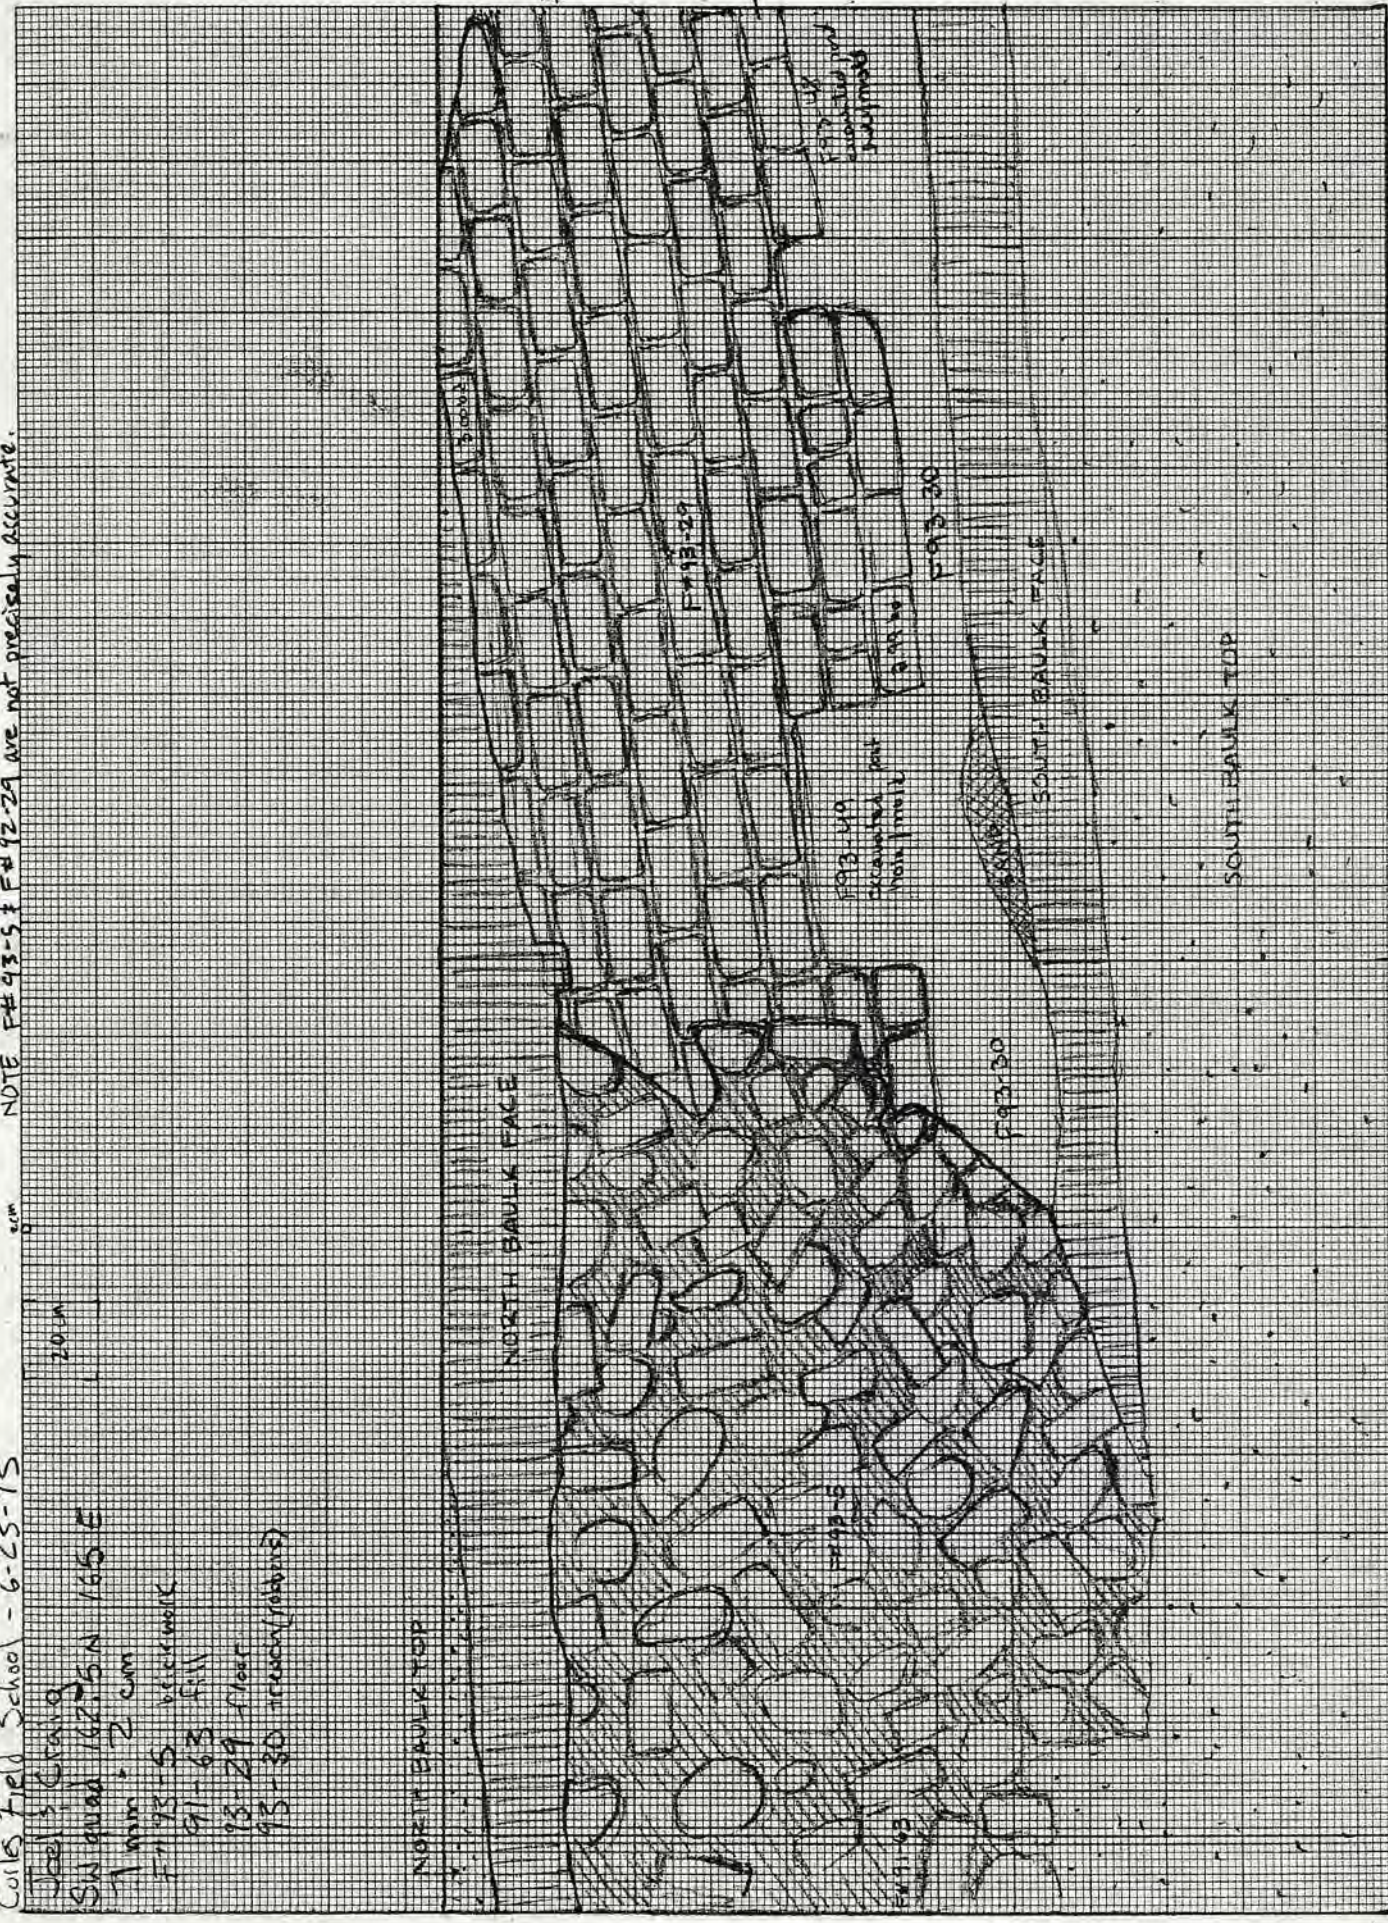
Joel's Grand
SW quad 162.5 N 165 E
1 mm = 2 cm
F# 93-5 bedrock
91-63 fill
93-29 floor
93-30 trench (robbins)

* Brick and rock drawings in
NOTE F# 93-5 & F# 92-29 are not precisely accurate.

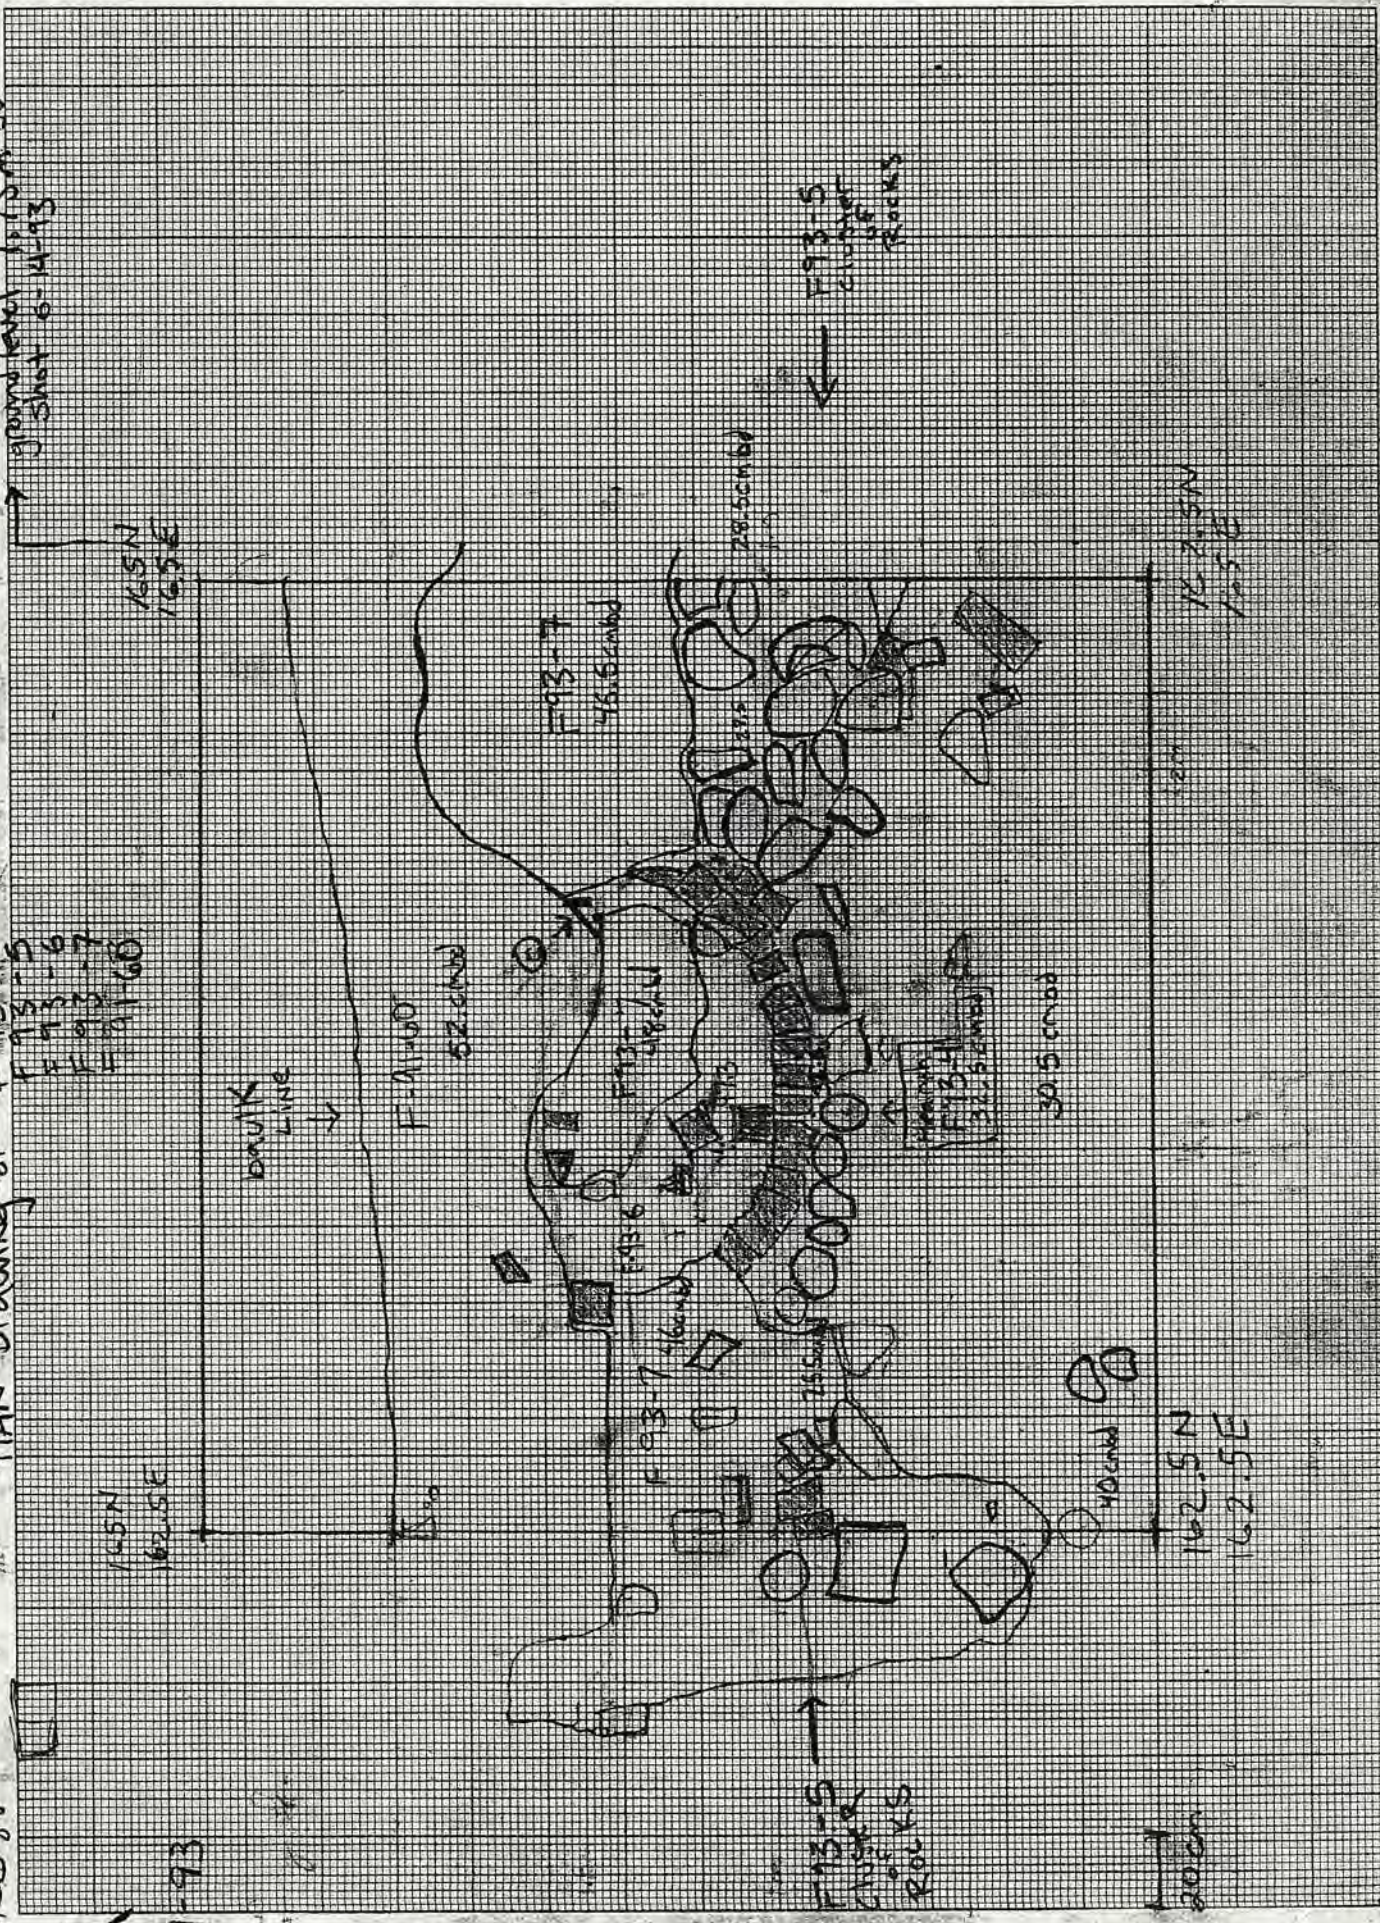
PLAN DRAWING OF F 93-41

F 93-5
F 93-6
F 93-7
F 91-60

KEY to PLAN DRAWING of F93-4; F93-5; F93-6; F93-7; F93-8

F93-4 C shaped hearth feature composed of brick and cobbles

F93-5 Disarticulated stones surrounding F93-4

F93-6 Dark brown sandy loam stain adjacent to F93-4

F93-7 Irregular stains surrounding hearth composed mostly of brick rubble

F93-8 Irregular brown organic feature surrounding hearth, heavily mottled with brick charcoal and char.

Cathy Poole removed by Cathy Poole in T93-3 in EU # 8027

See plan map for exact location, small localized feature.

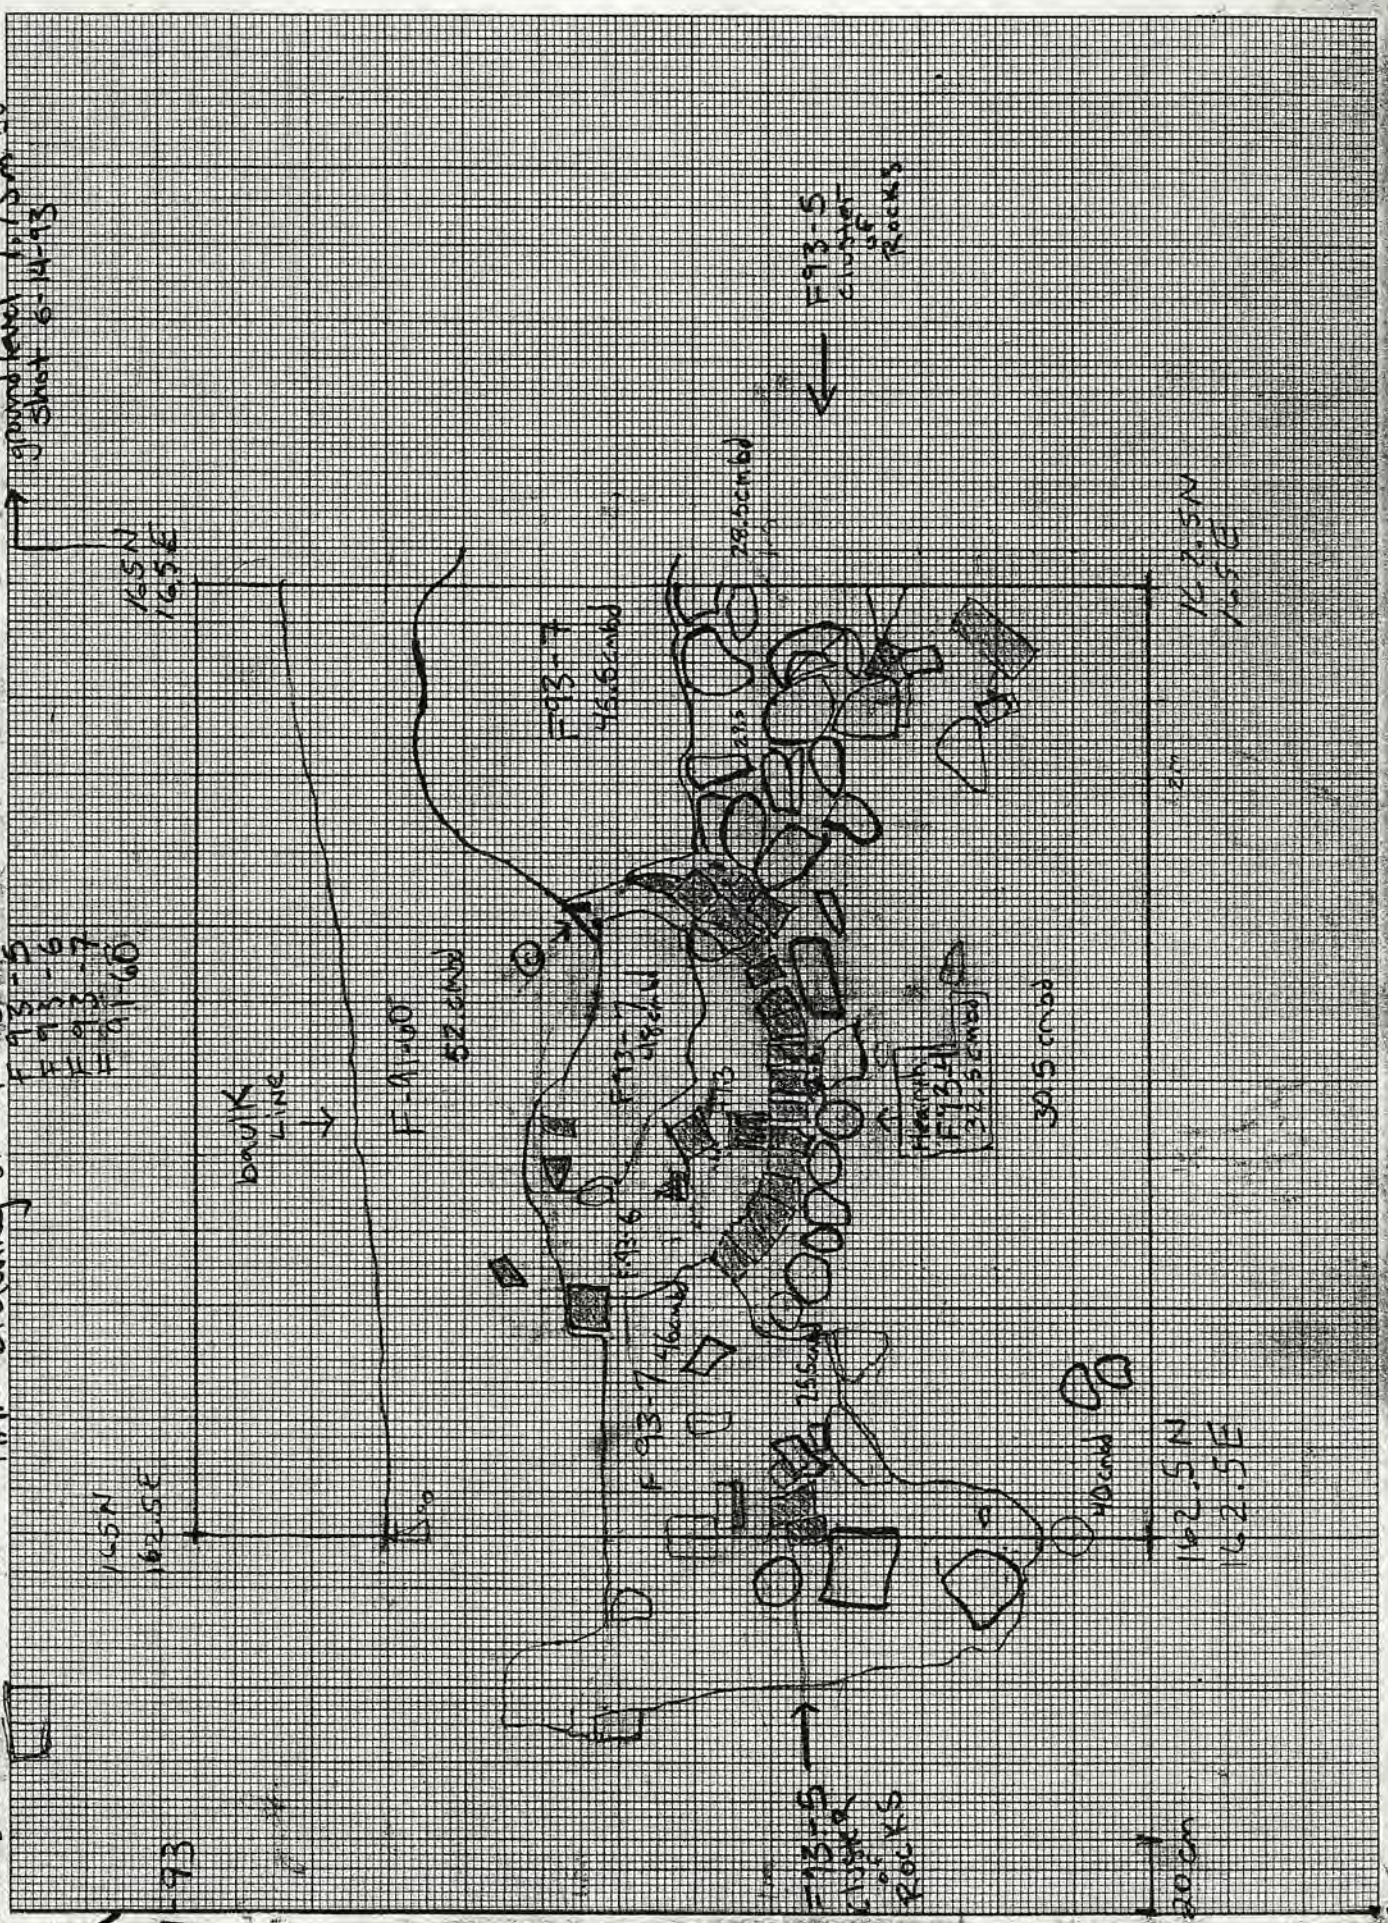
PLAN Drawing of F 93-H

KEY to Plan Drawing of F93-4; F93-5; F93-6; F93-7; F93-8

F93-4 C Shaped hearth feature composed of brick and cobbles

F93-5 Disarticulated stones surrounding F93-4

F93-6 Dark brown sandy loam stain adjacent to F93-4

F93-7 Irregular stain surrounding hearth composed mostly of brick rubble

F93-8 Irregular brown organic feature surrounding hearth, mostly made of with brick charcoal and clay.

F#93-7 contains silt/water deposit and destruction debris. Soil is dark and silty in some areas while light and sandy in others. Excavation of #93-7 exposed large amounts of cobbles and whole bricks - perhaps associated w/ F# 93-4. A few (appr. 5) nails and a brass straight pen were found. F#93-7 surrounds F# 93-5

- excavation consisted mainly of cleaning F#93-7 fill from in and around F#93-5 (disarticulated stones)

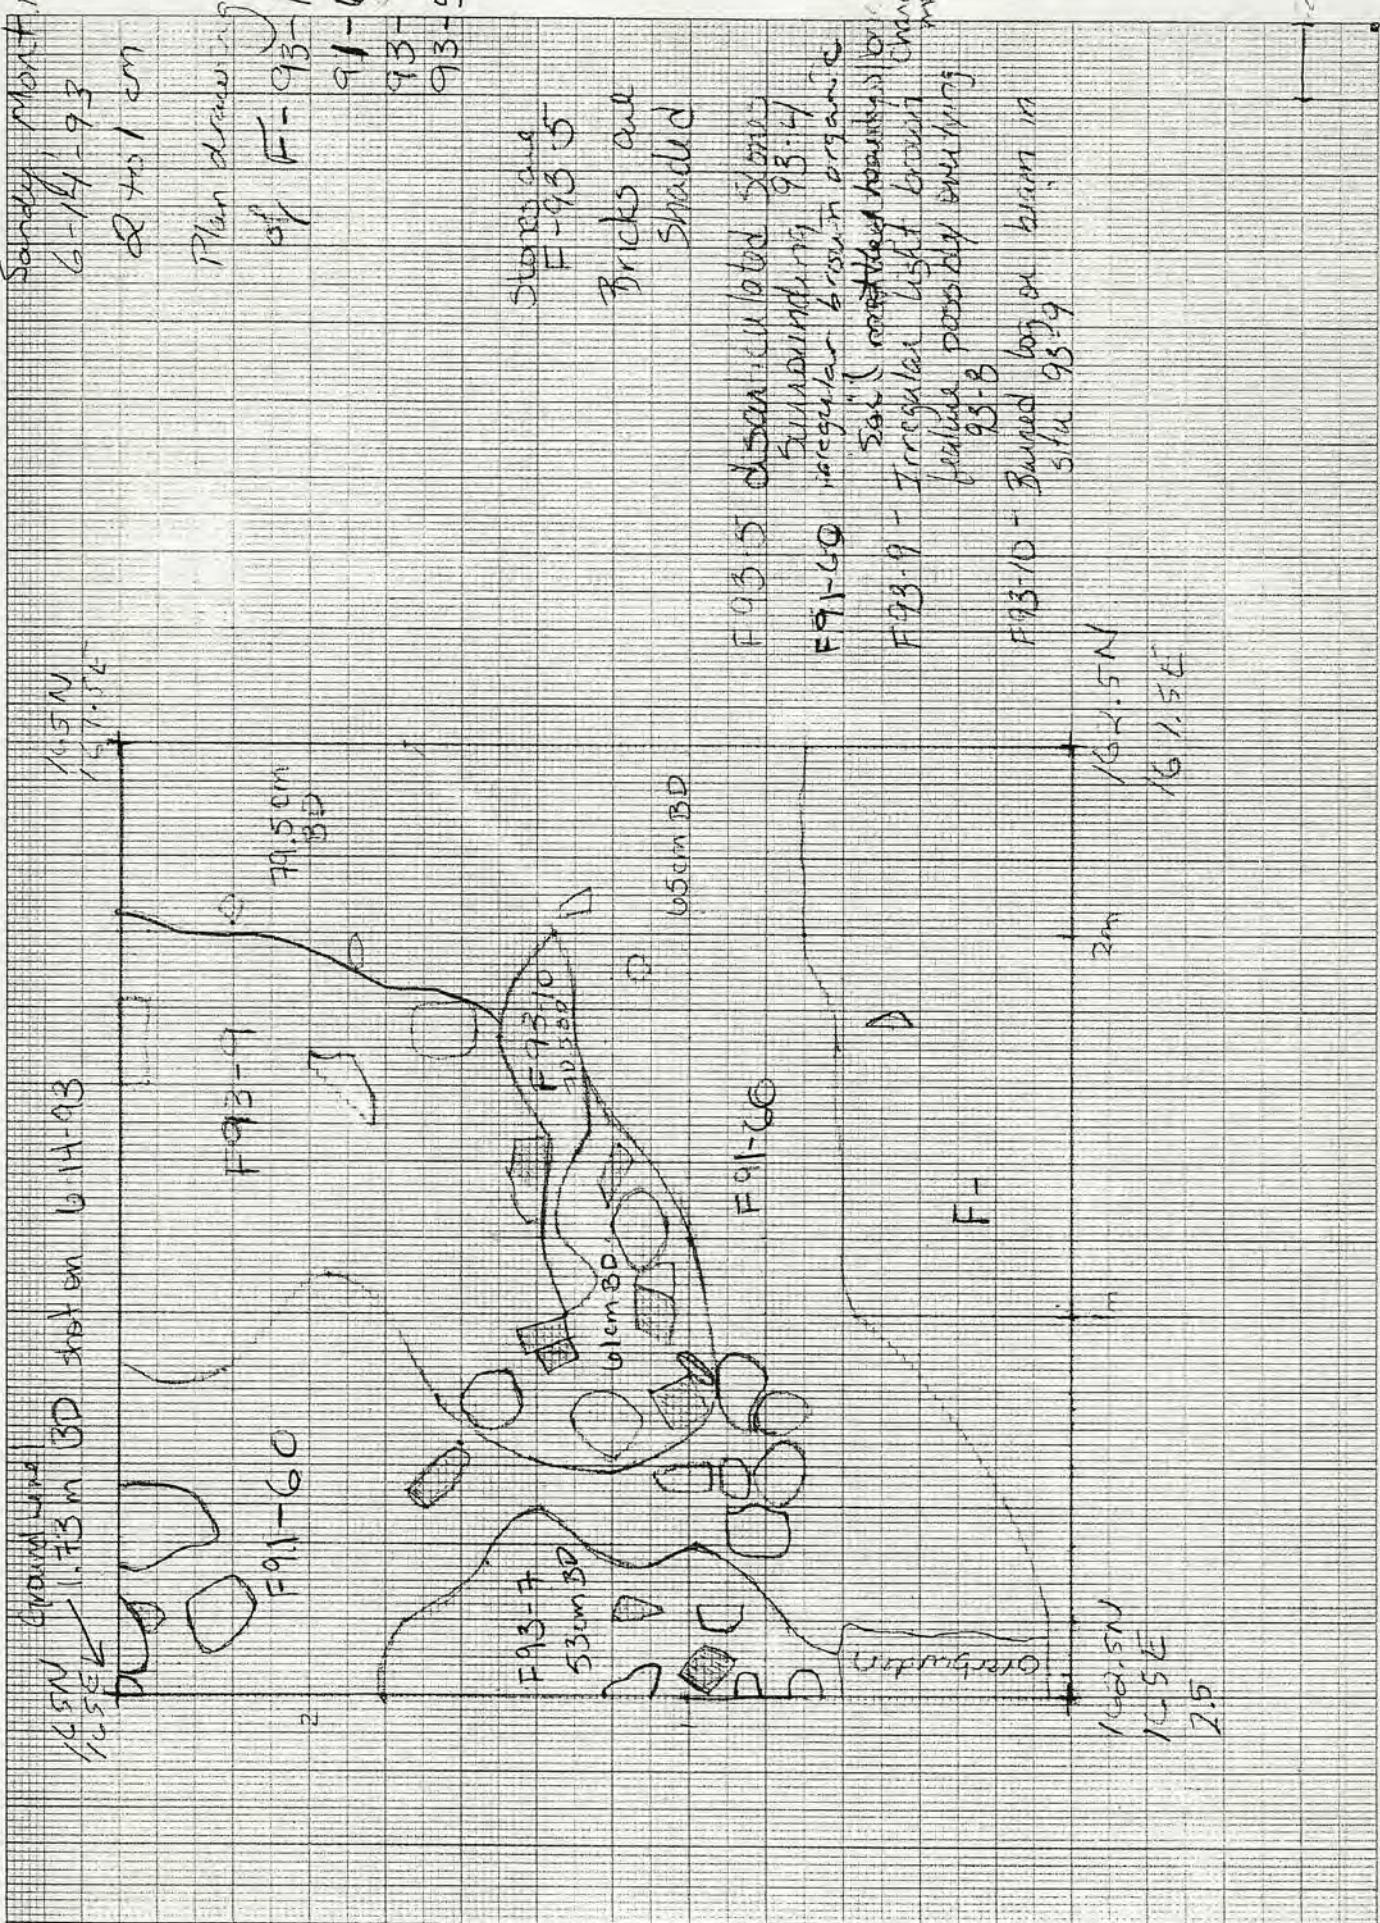
Plan drawing

of F-93-10
91-60
93-9
93-5

Stoney aug
F-93-5

Bricks are
shaded

F93-5 disarticulated bones

F91-60 irregular brown organic

F93-9 - Irregular light brown
featuring possibly emburying

F93-10 - Burned bog or beam in
situ 95-9

Soil (possibly heavy) brick
Charcoal
mortar

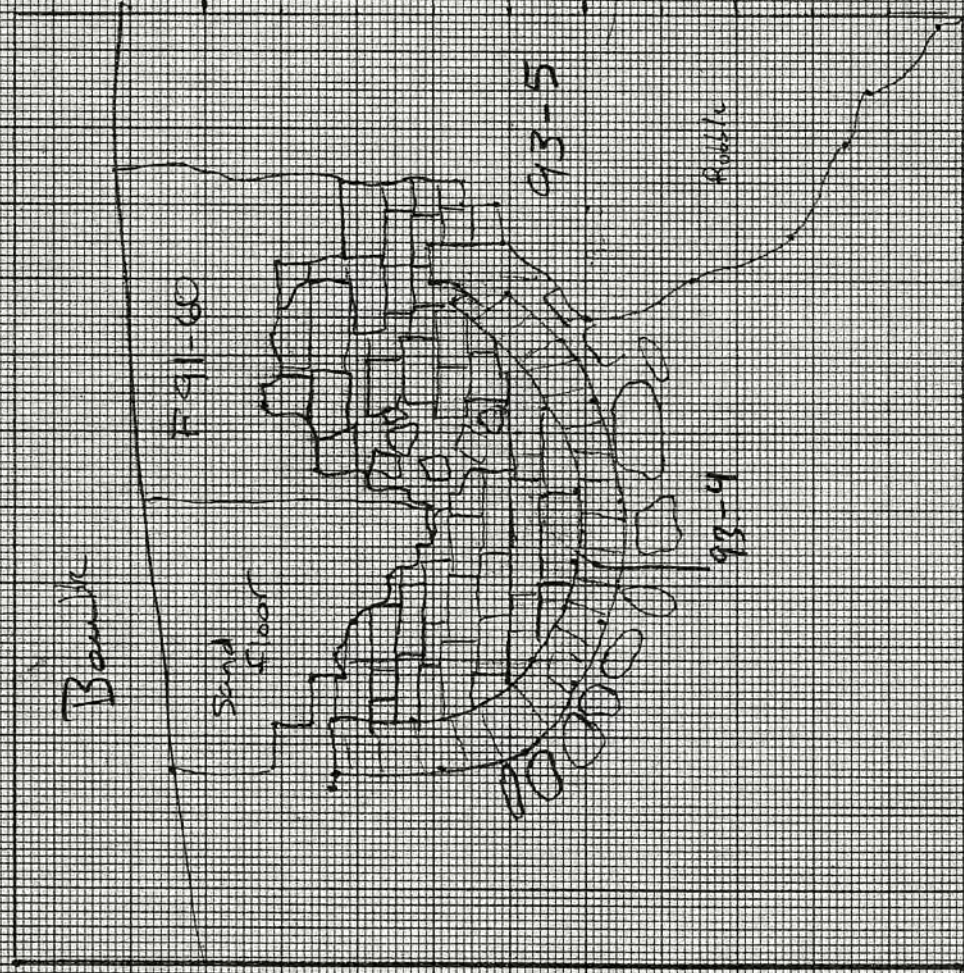
Curle's Field School 6-23-93 41 HE 388

Katherine & Jeff
SW Quad: 162 SW 162 SE
162 F 250
F 93.4
9

F-93-5 disarticulated stone
surrounding 93-4
F-91-60 irregular brown organic
Soil ~~moist~~ heavily brick
F-93-9 - Irregular light brown
feature possibly emptying
93-8
F-93-10 - Burned log or branch in
situ 93-9

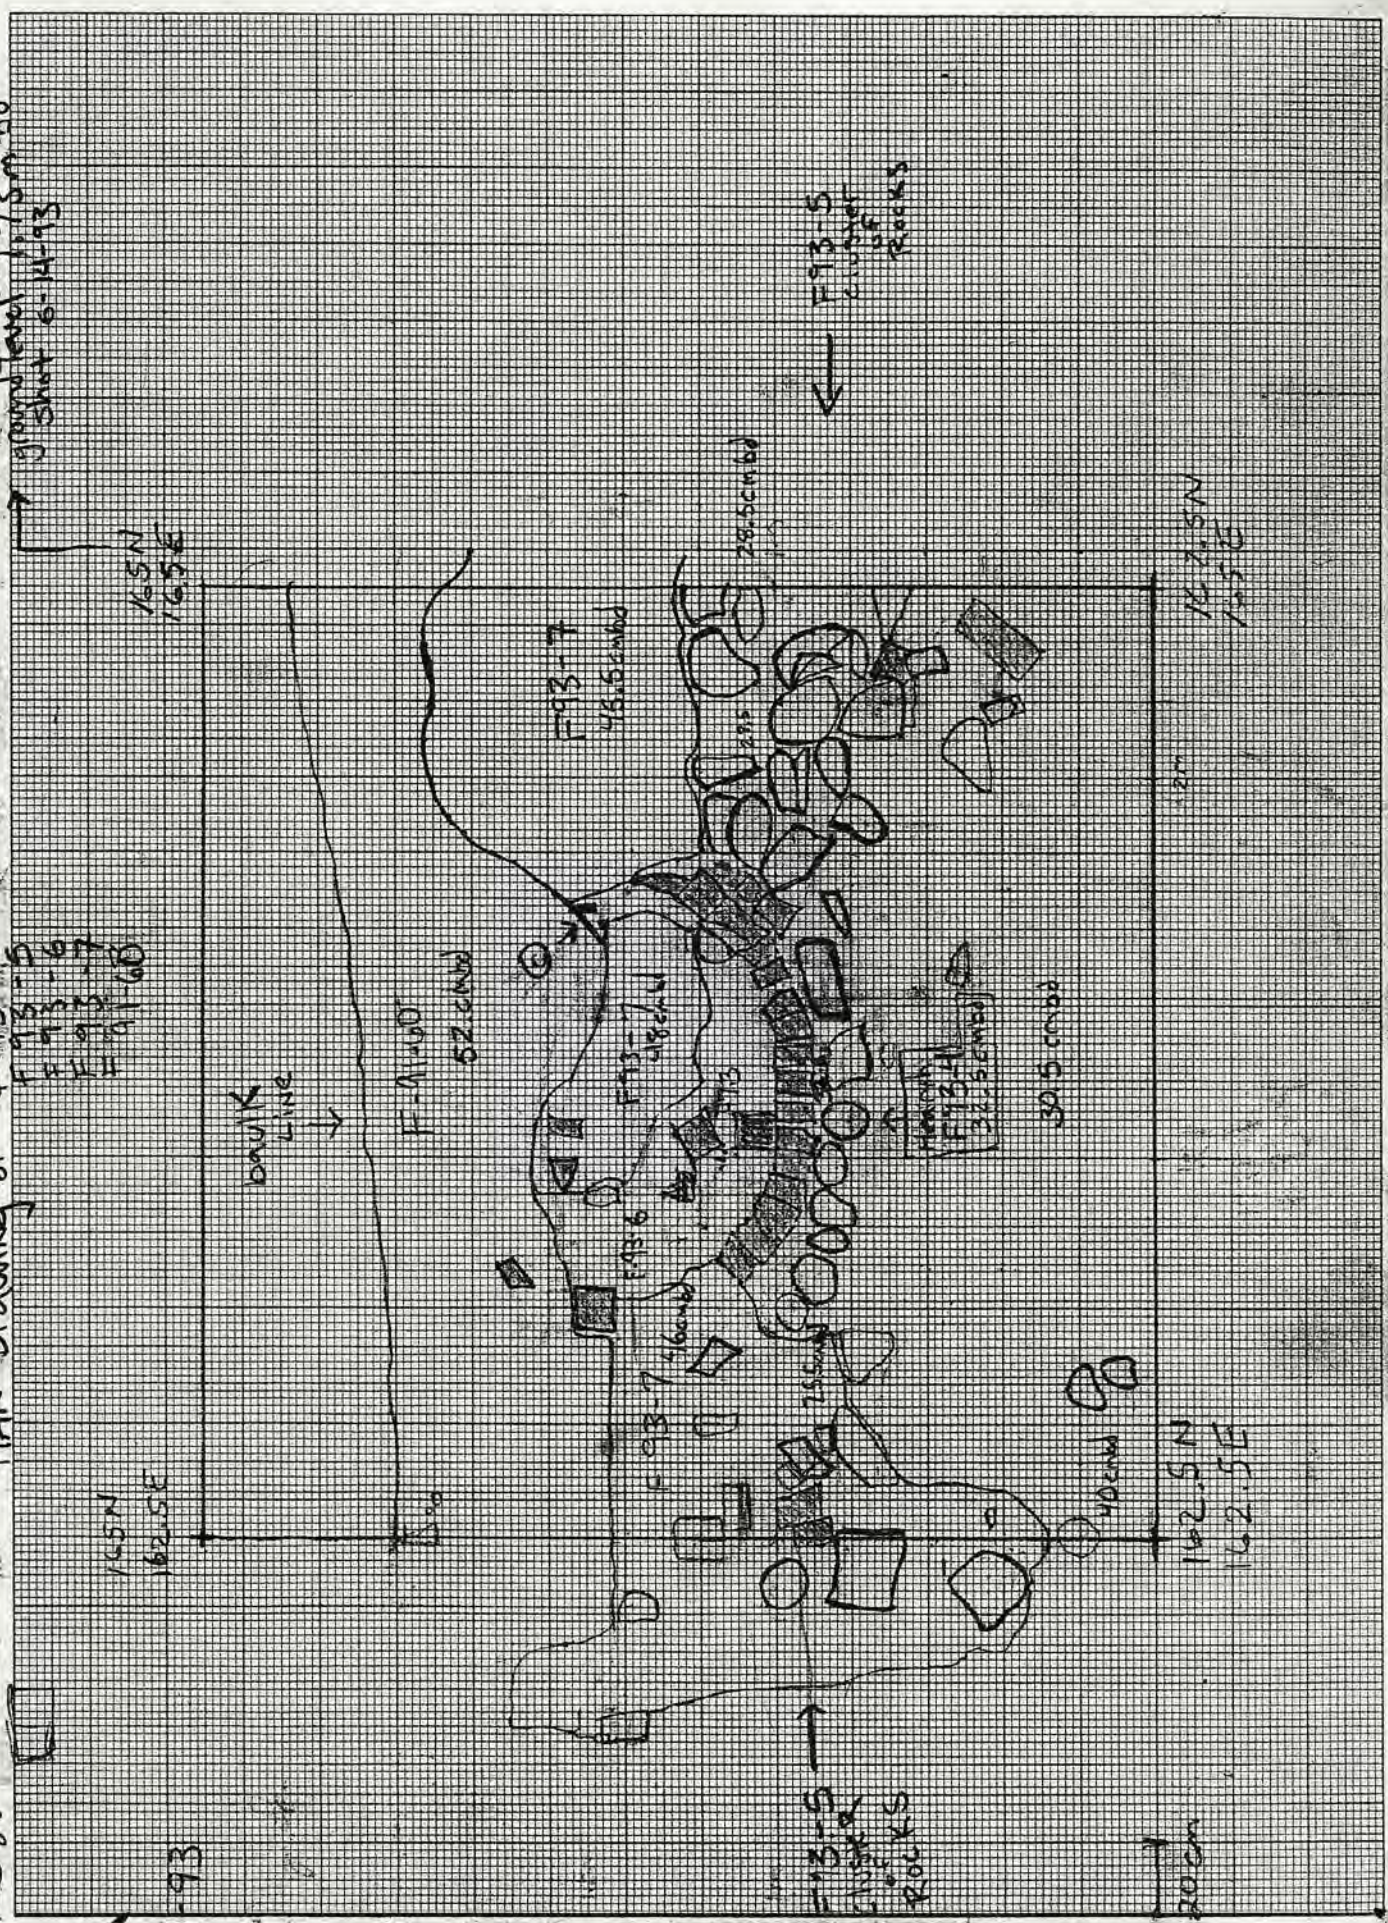
PLAN Drawing of F93-F1

KEY to Plan Drawing of F93-4, F93-5, F93-6, F93-7, F93-8

F93-4 C shaped hearth feature composed of brick and cobbles

F93-5 Disarticulated stones surrounding F93-4

F93-6 Dark brown sandy loam stain adjacent to F93-4

F93-7 Irregular stain surrounding hearth composed mostly of brick rubble

F93-8 Irregular brown organic feature surrounding hearth, mainly modeled with brick charcoal and char.
