Feature Form

Site # 44HE388

Curles Field School 6-23-93 44 HE 388

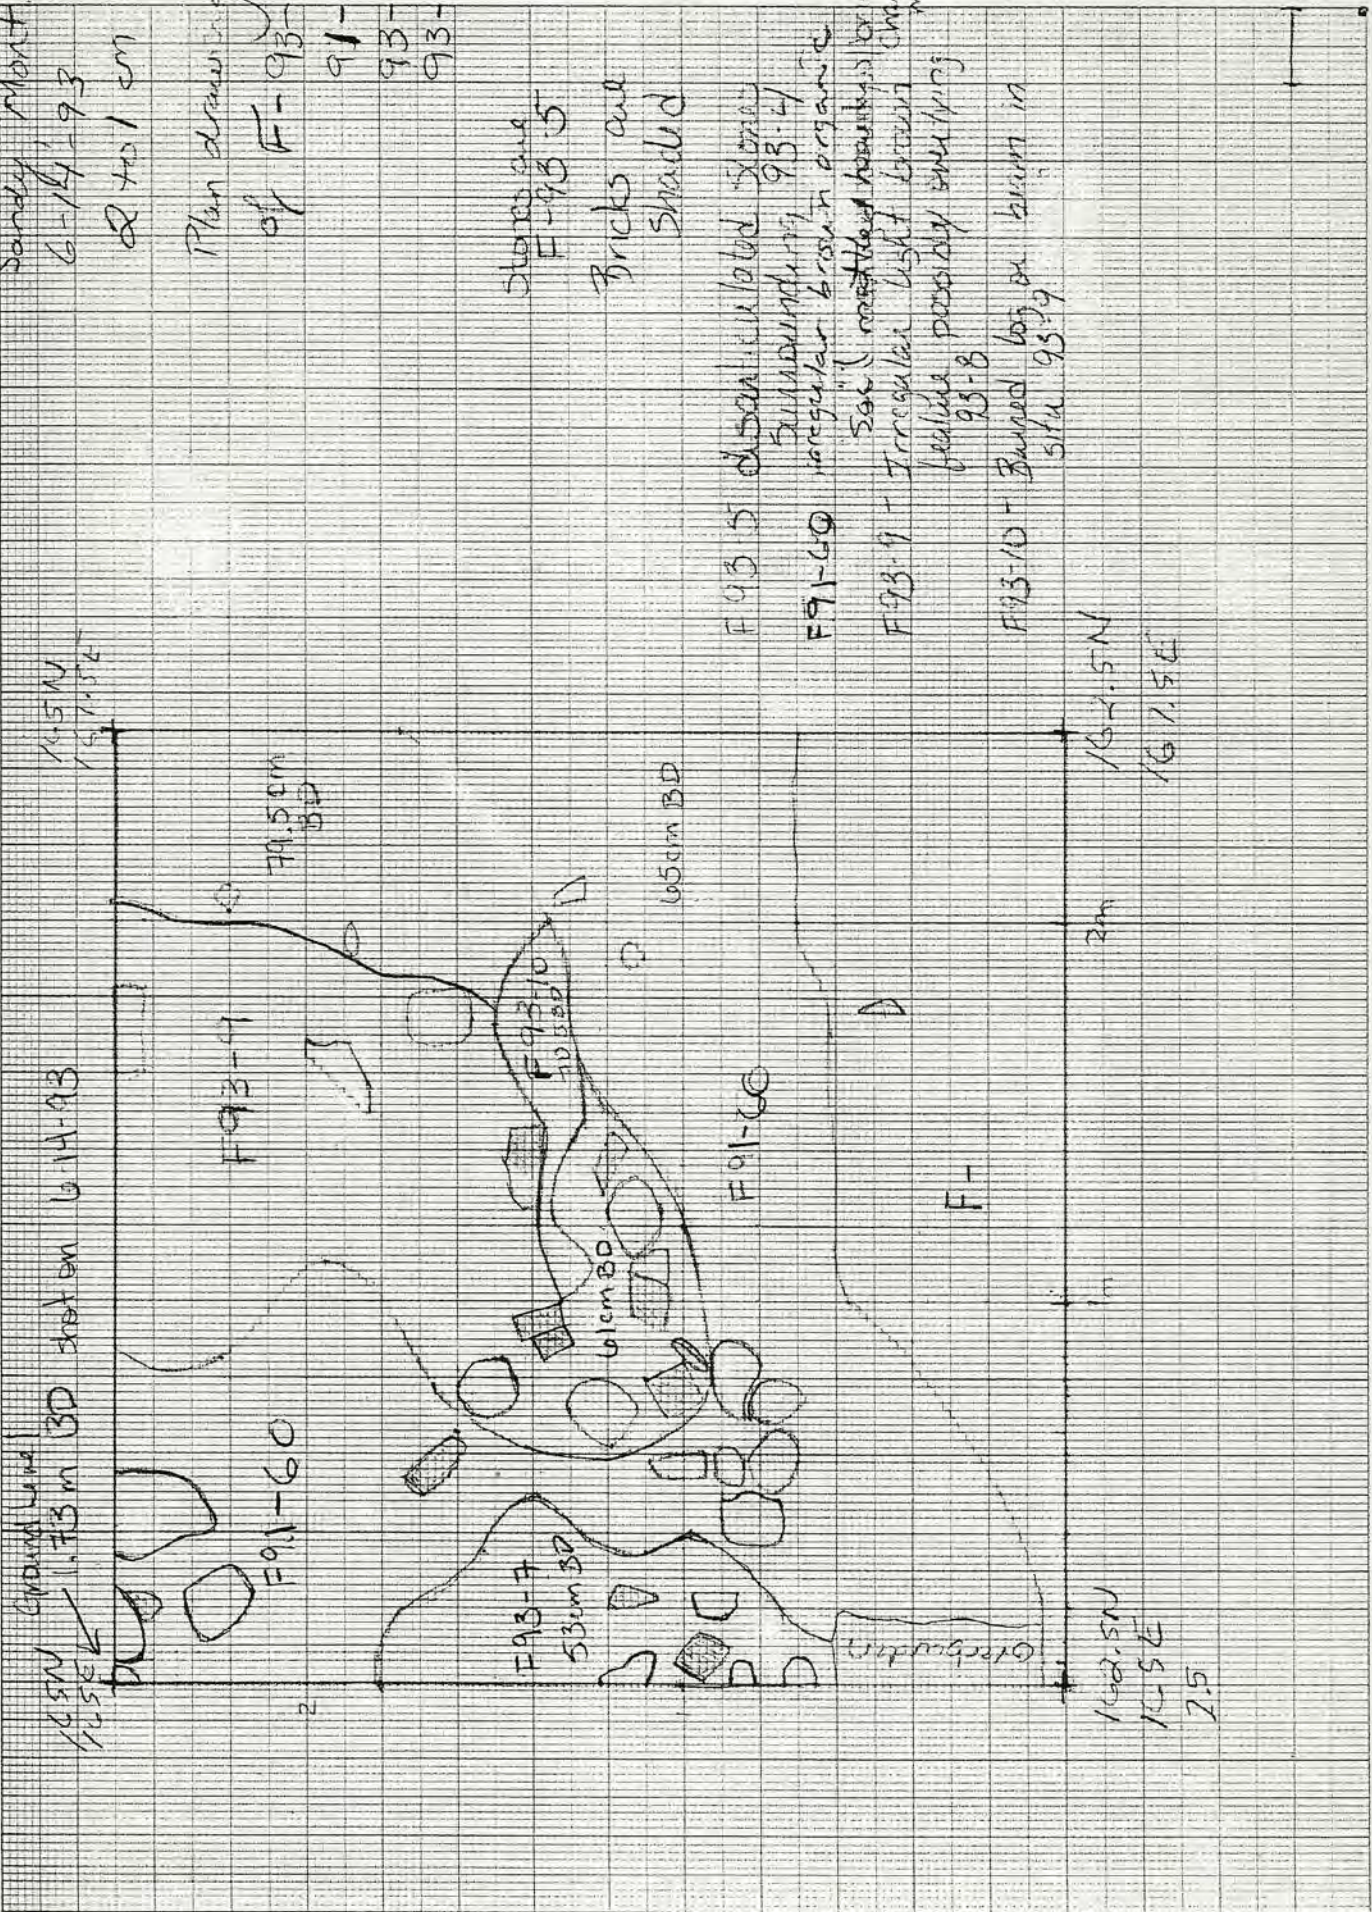
Plan drawing
of F-93-10
91-60
93-9
93-5

Stores are
F-93-5
Bricks are
shaded

F-93-5 disarticulated stone
surrounding 93-4
F-91-60 irregular brown organic
Soil ~~moist~~ heavily brick
F-93-9 - Irregular light brown
feature possibly emptying
93-8
F-93-10 - Burned log or branch in
situ 93-9
