# Feature Form

Site # 44HE388

Feature # 94-28

Type of Feature Brick rubble from destruction of Harris cellar

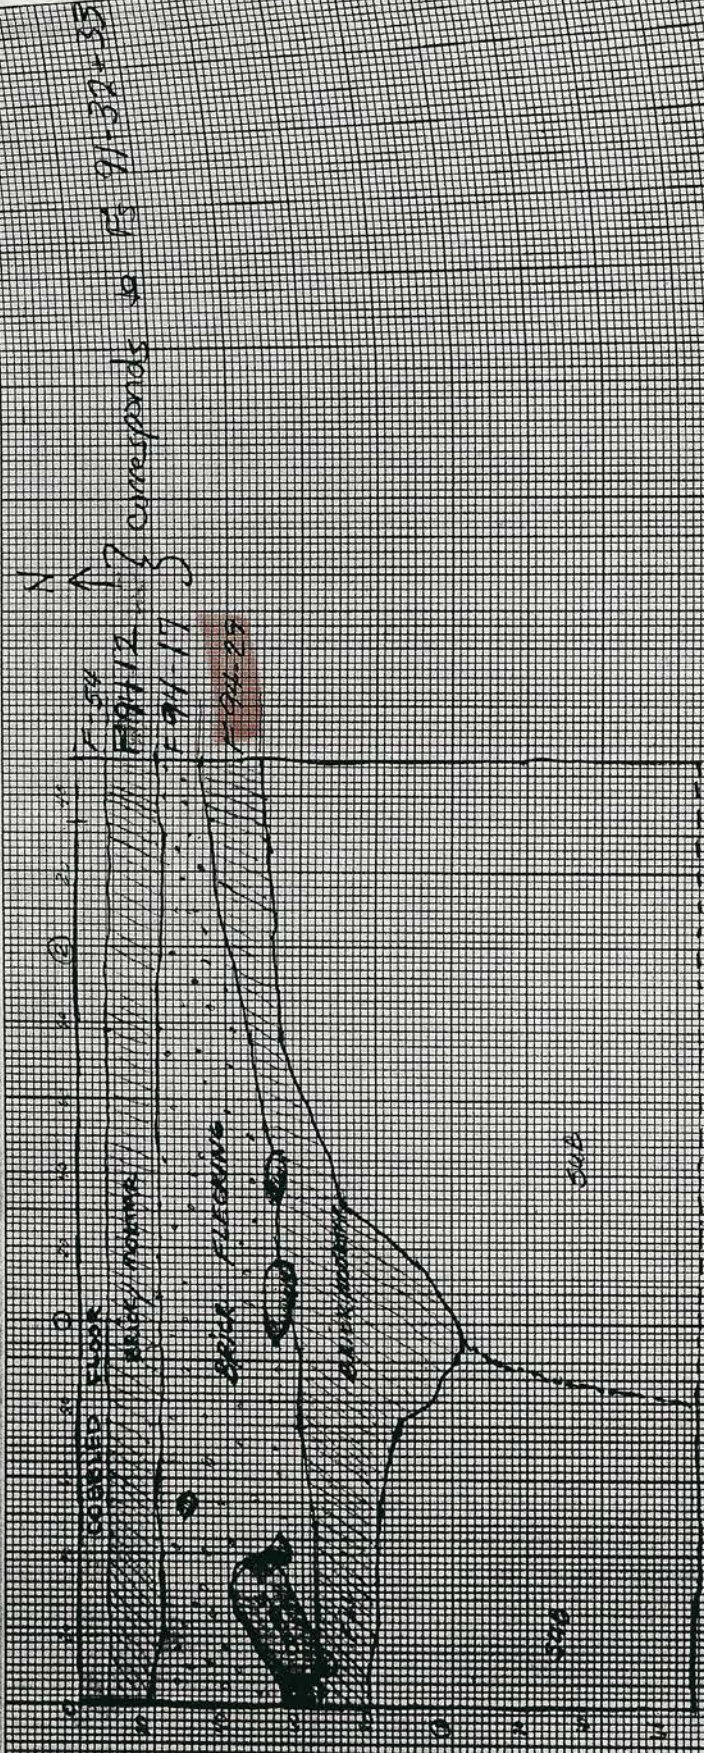
NORTH PROFILE - BROWN'S TRENCH  
167.5 N - 100 E / 167.5 N - 162.5 E

This fill had several layers. On top was a very sandy layer that was extremely variegated and very soft. Towards the bottom of the layer there were pockets of grey soil with lots of ash. They were similar to what was in the next layer but were not high spots. The next layer down was greasy ash fill. The top two layers were full of artifacts - a stoneware bowl, pipe stems (local + ball clay), lots of nails +

roofing tiles, some westward, tin-  
enamelled. The next layer down was  
a medium brown with charcoal +  
brick flecks and was a little bit  
harder to dig. Beneath that was  
more sandy wash lens. There were  
very few artifacts in these 2 layers.  
Beneath that was subsoil.

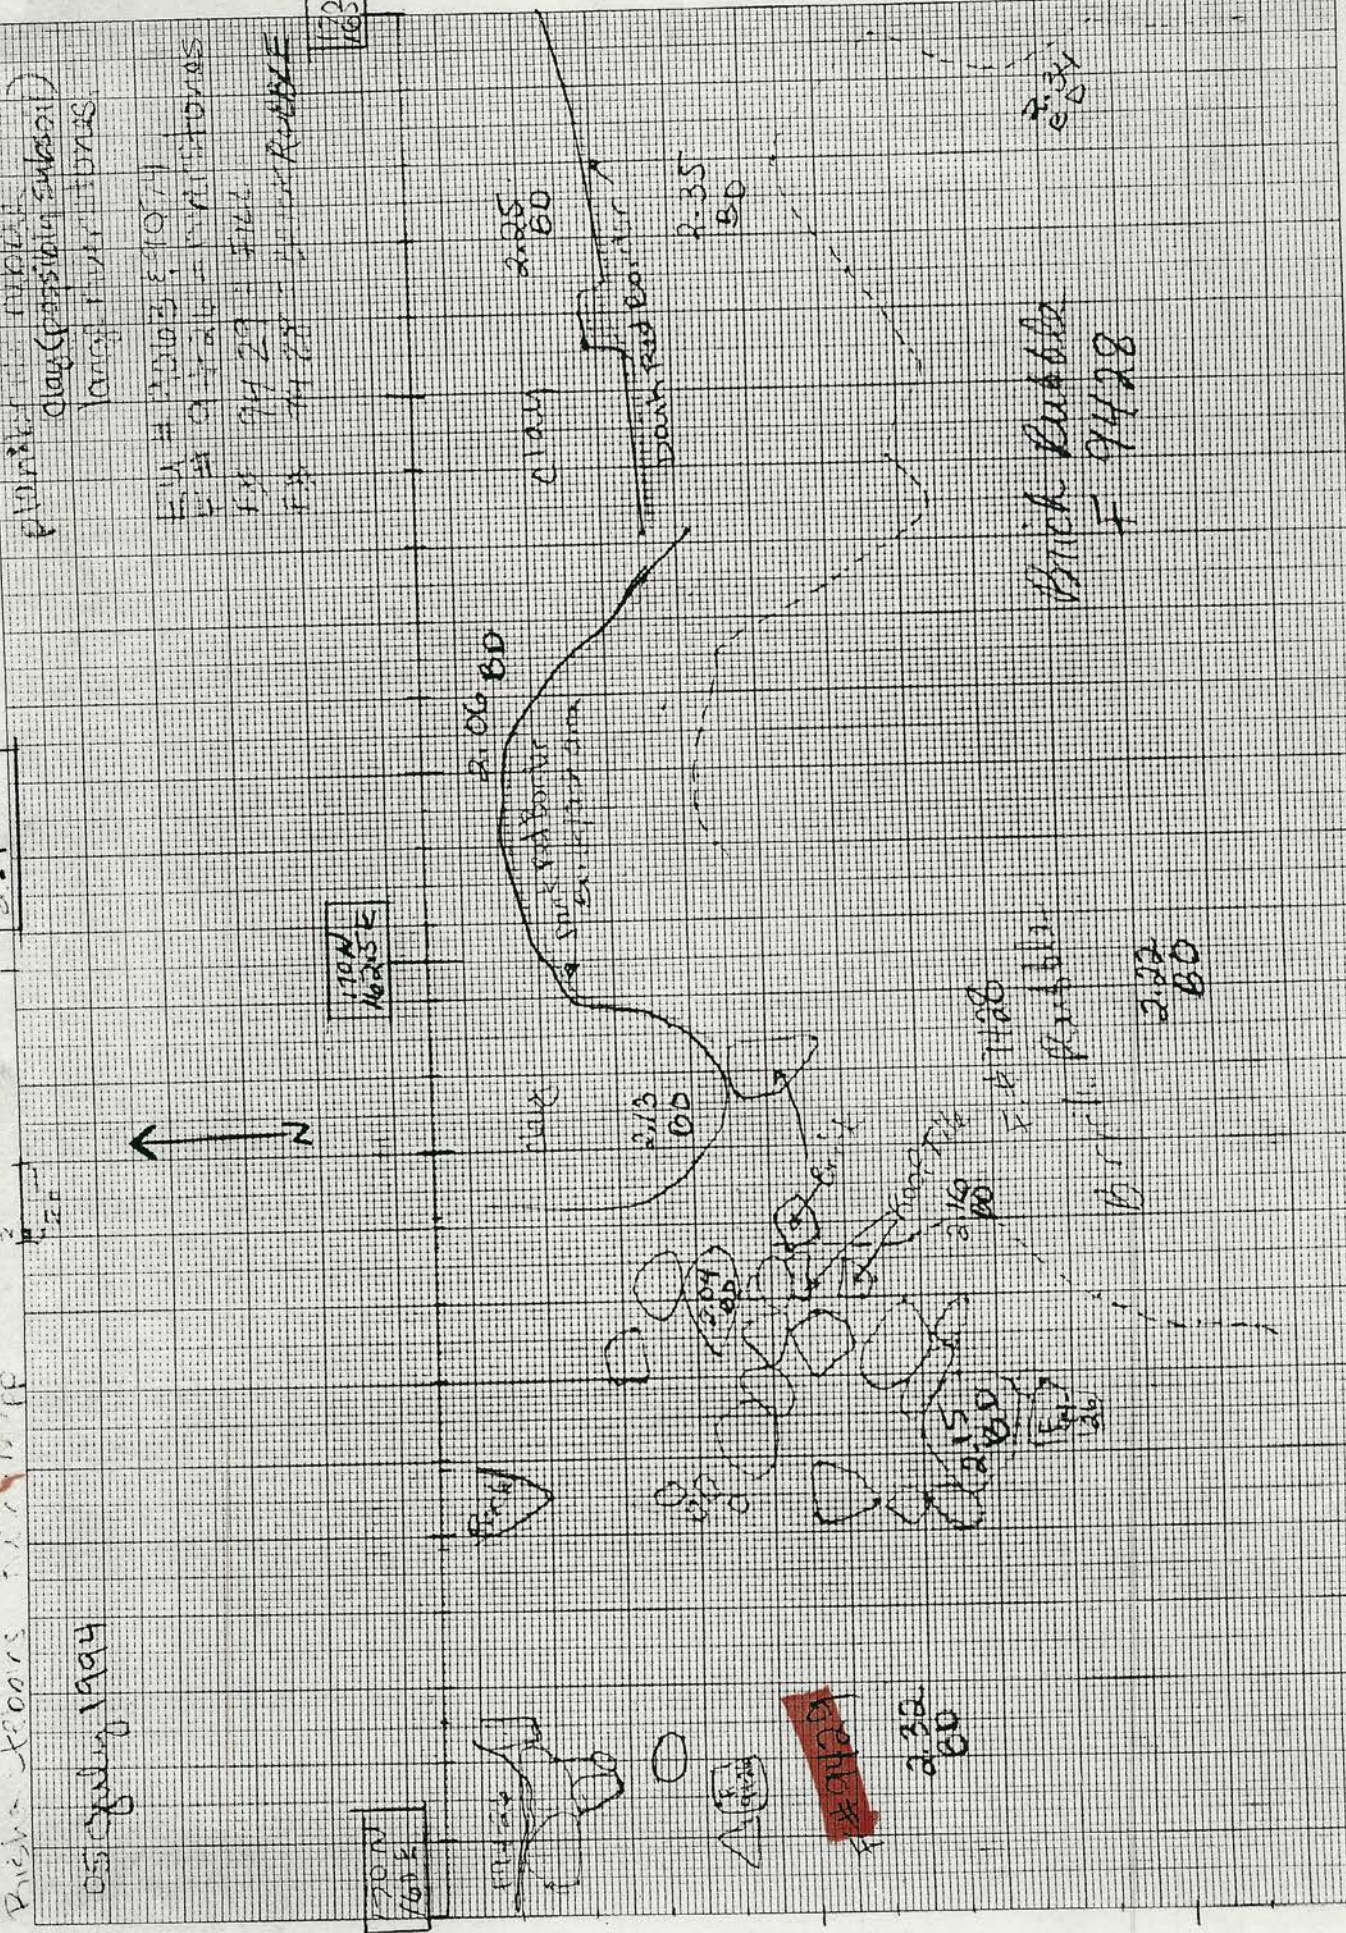
Dale & Snop  
Buck's floors  
05/29 July 1994

FLORIDA  
clay (possible subsoil)  
large FLUTATIONS  
EU # 9403 E91074  
F # 9428 E911074  
F # 9429 E911074  
F # 9428 - HOUSE RUMBLE  
701  
165 E

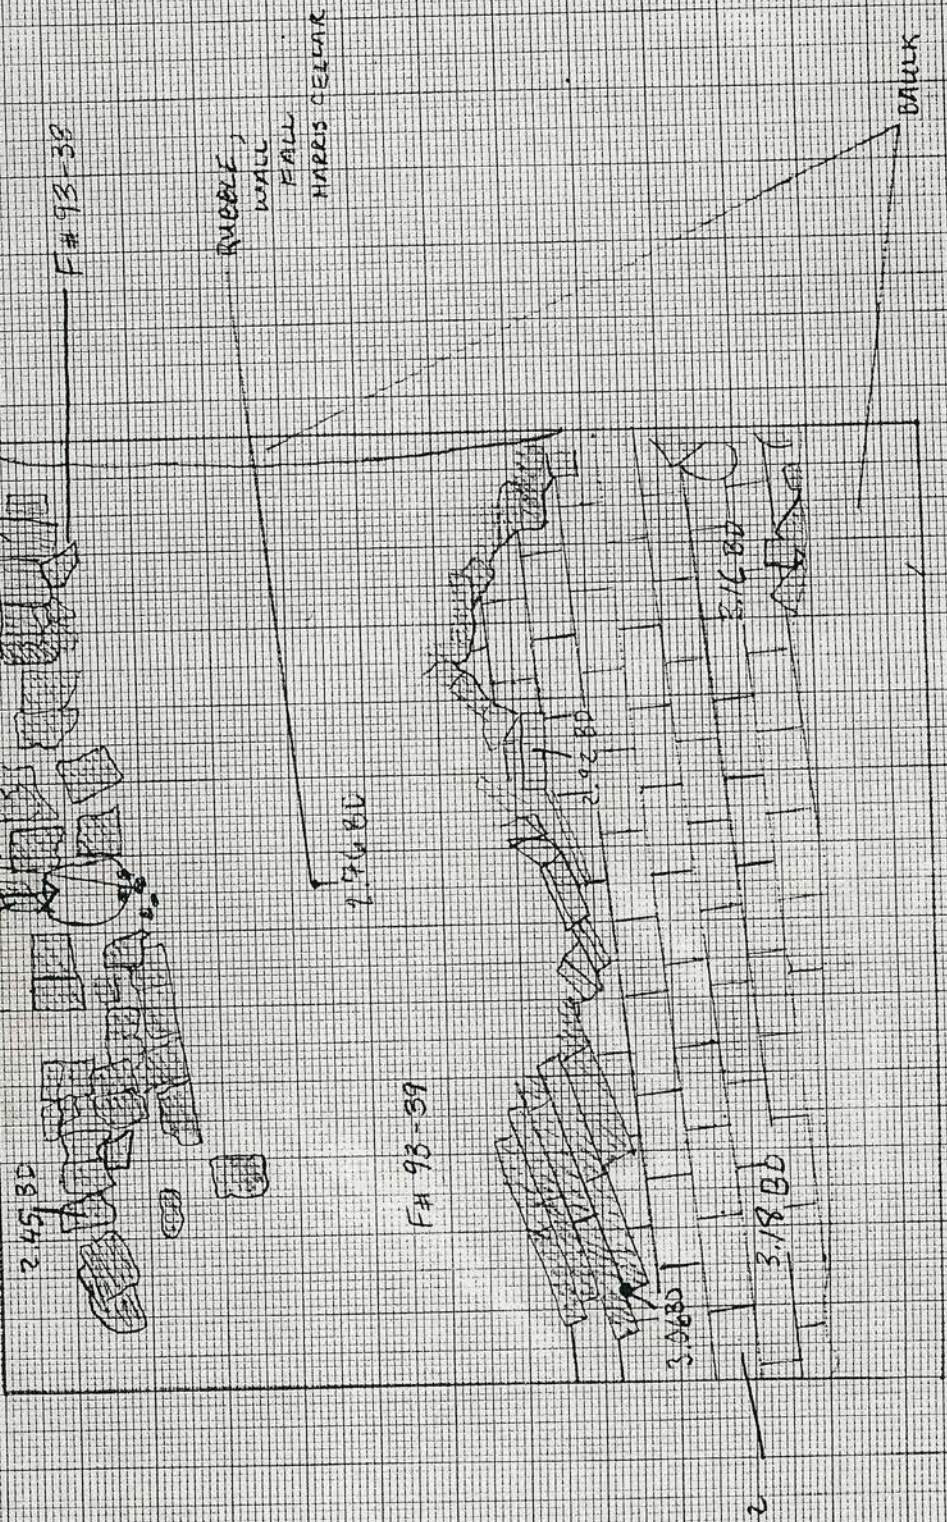
F94-30 (Psst)

RUBBLE  
WALL  
HARRIS CELLAR

DRAIN

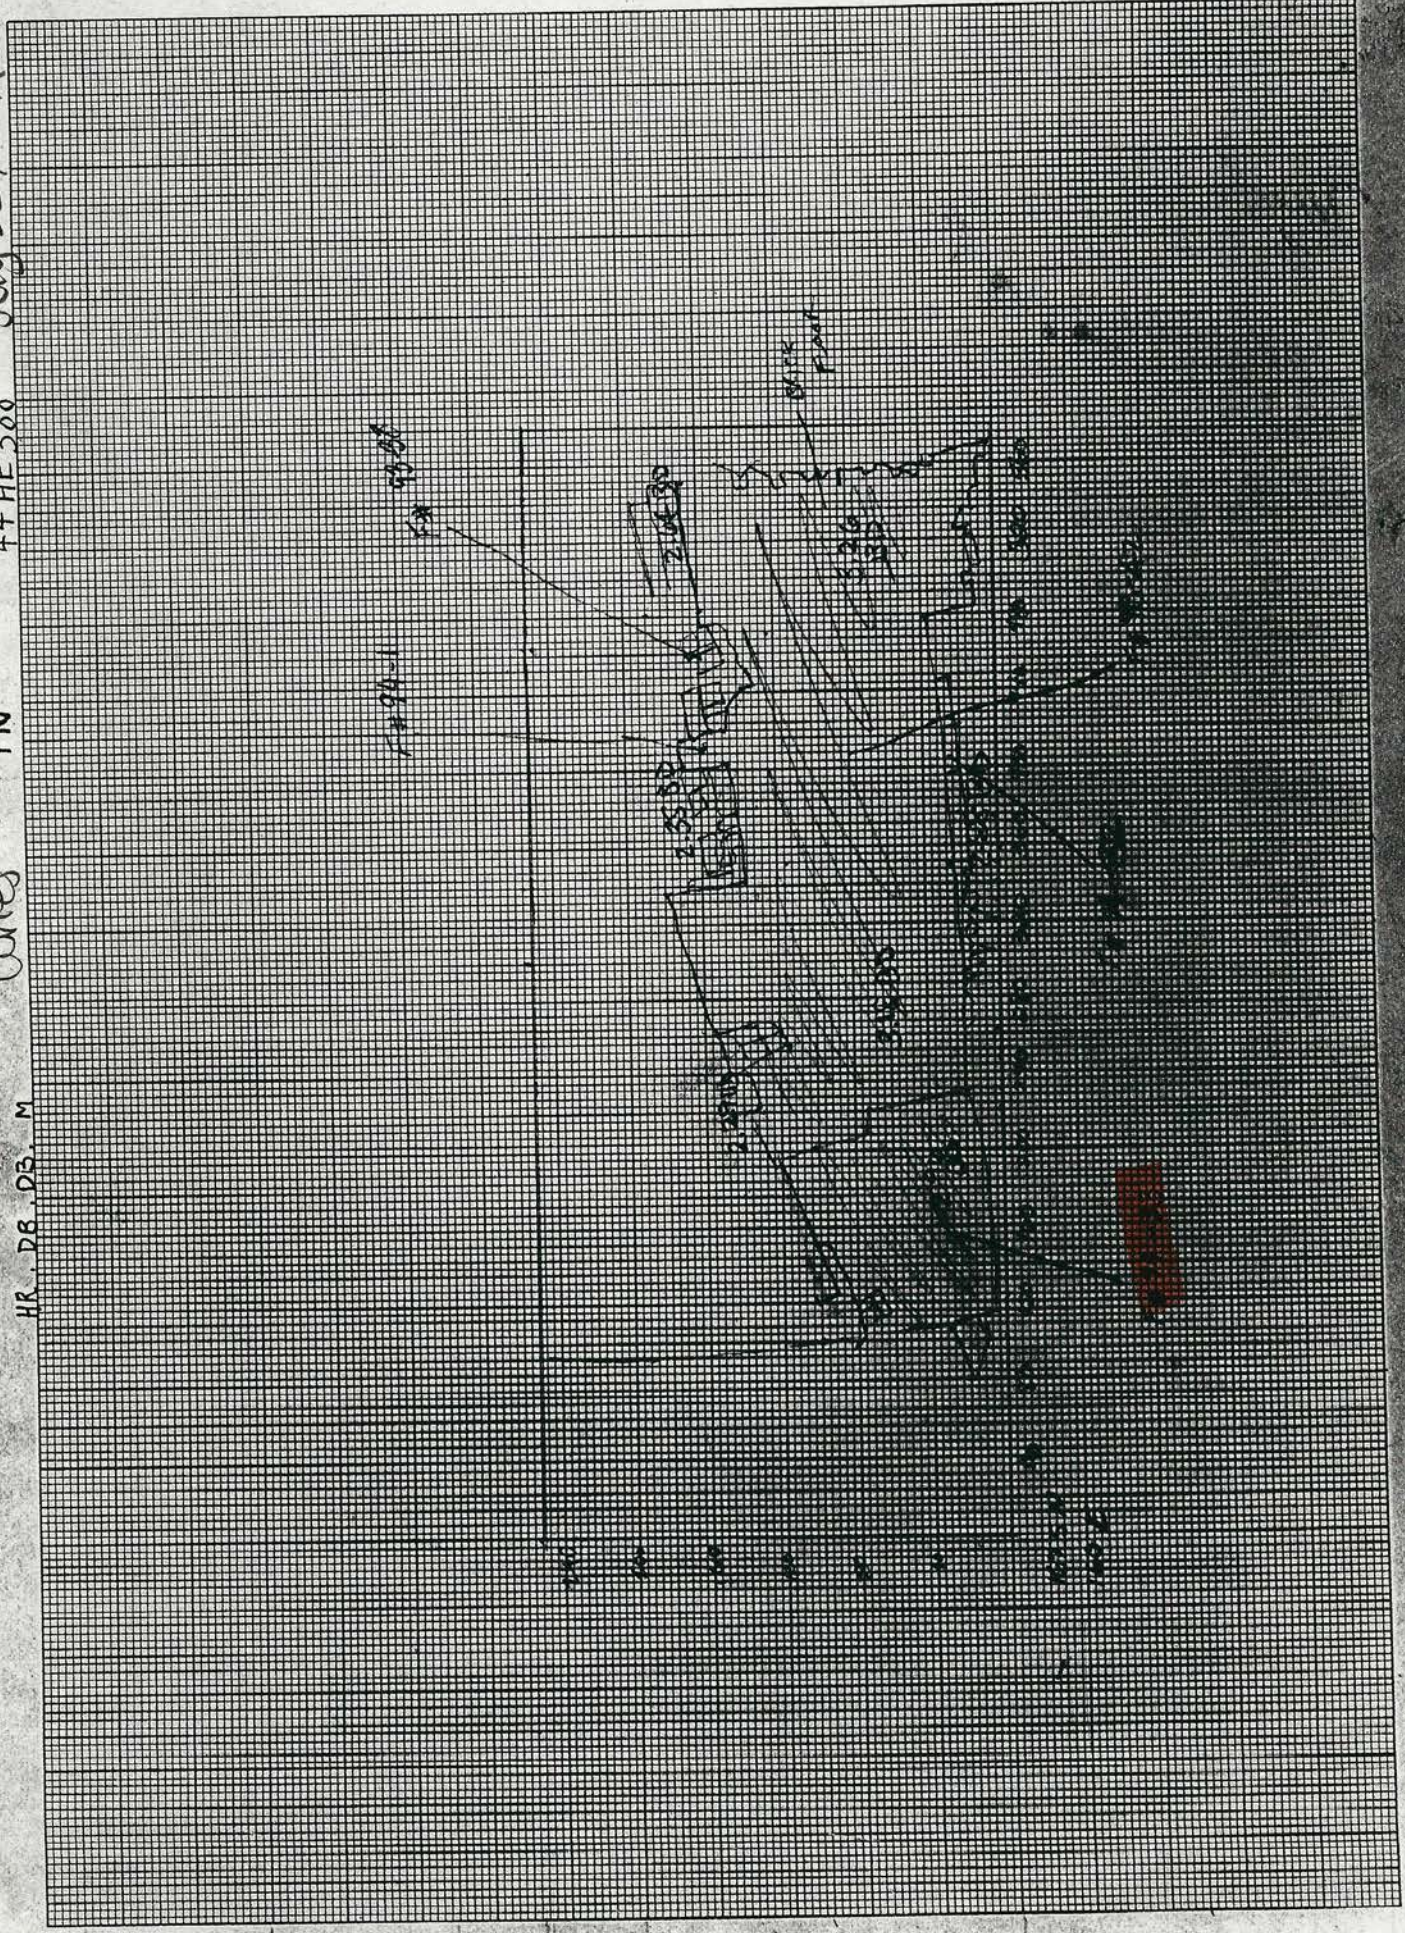
Type of Feature Raised brick section of Harris Floor (cellar)

1 brick thick brick platform set on dirt 12.5 cm. higher than rest of brick floor. Platform appears to be slightly skewed from the rest of the floor.

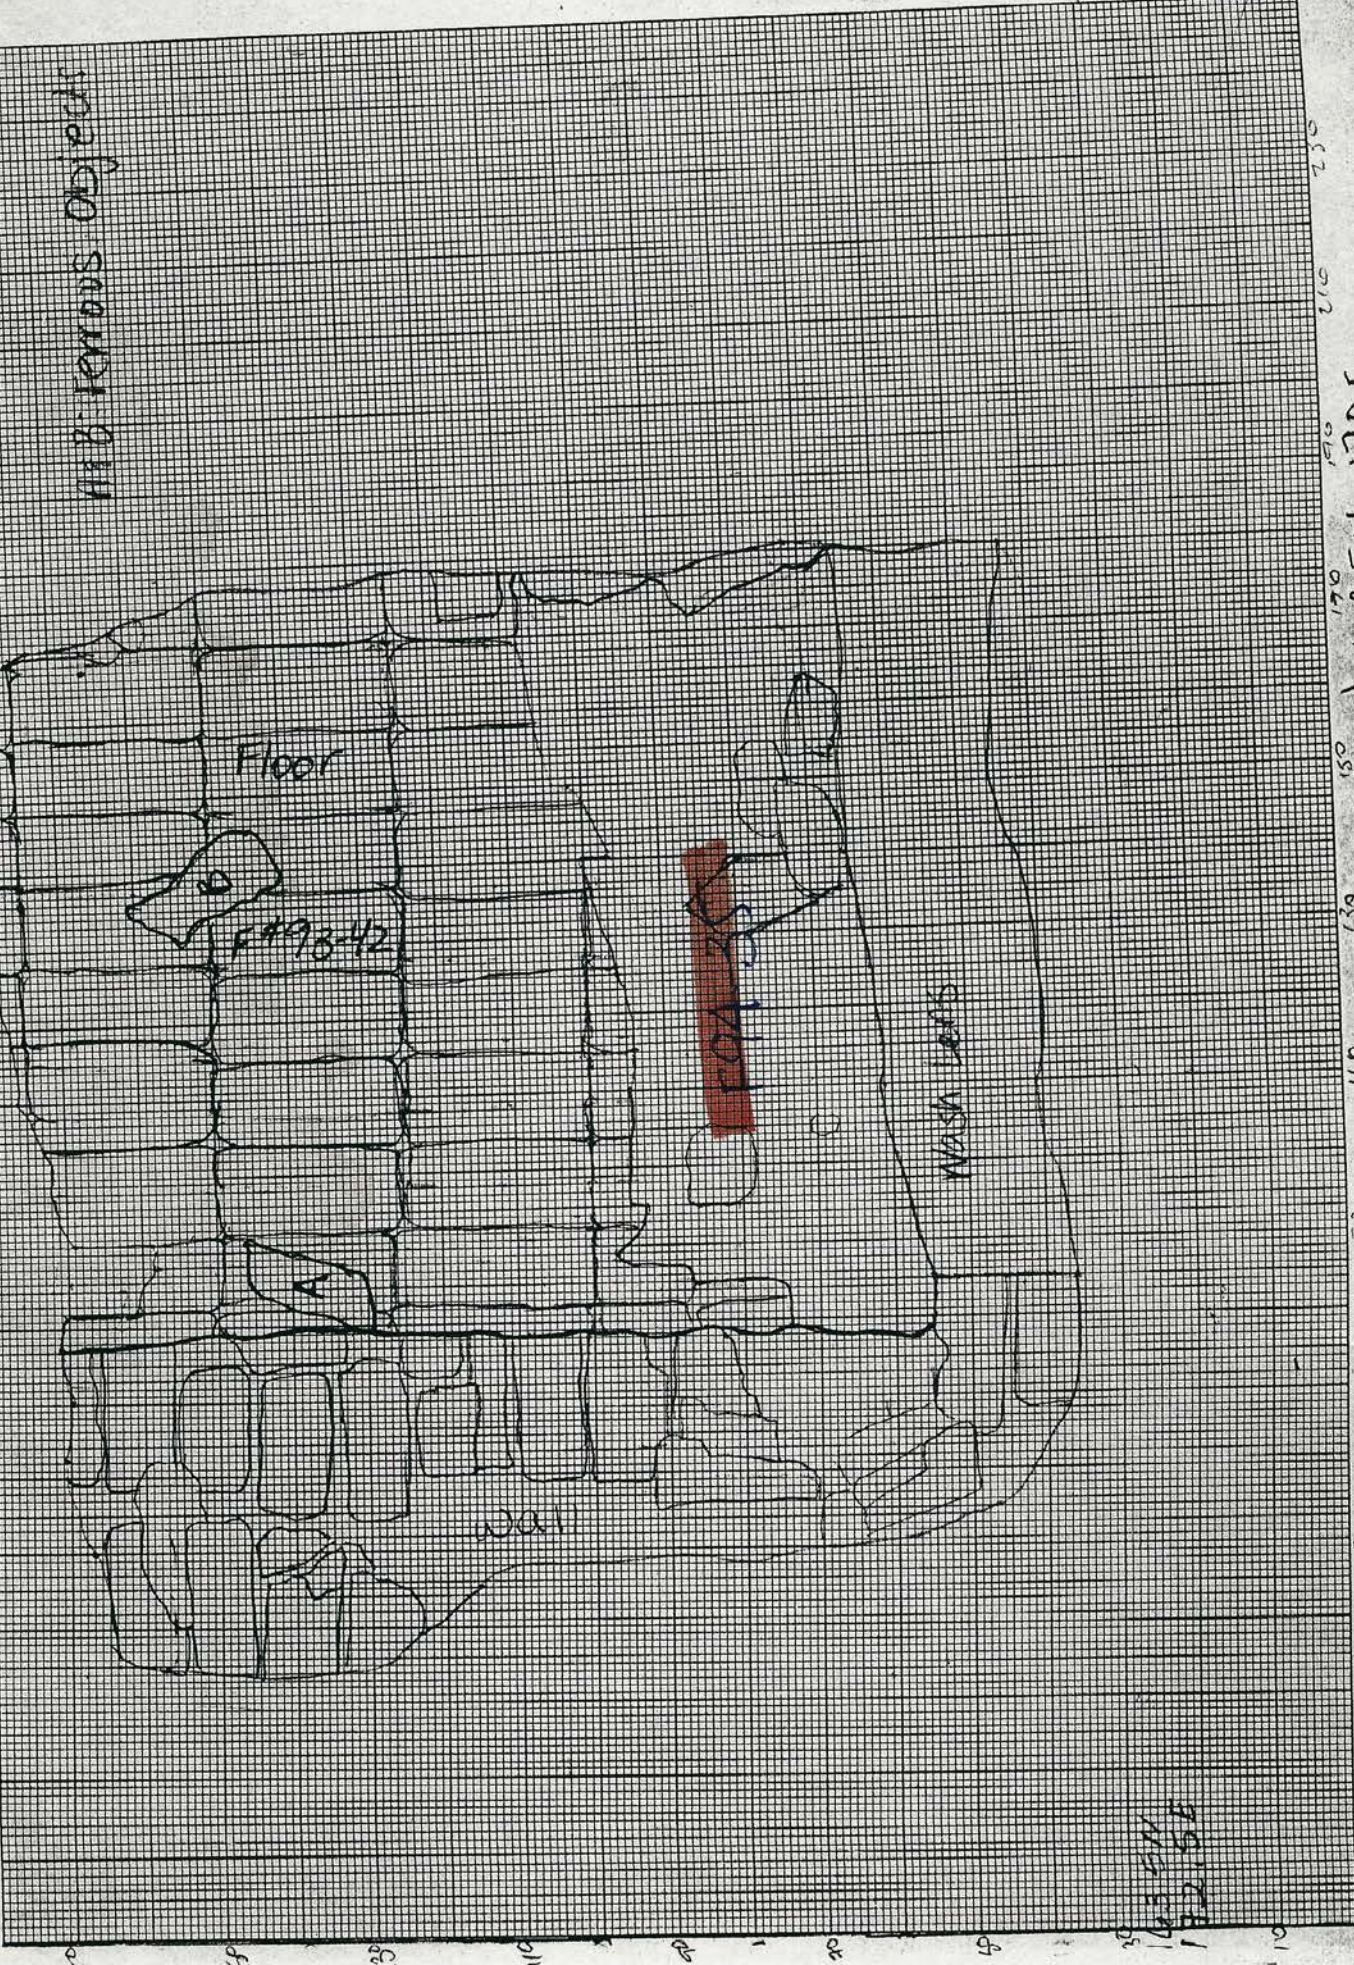
Type of Feature East wall of Humns house.

Rubble filled linear stain parallel to flow

Southwest Corner Harris Galloway

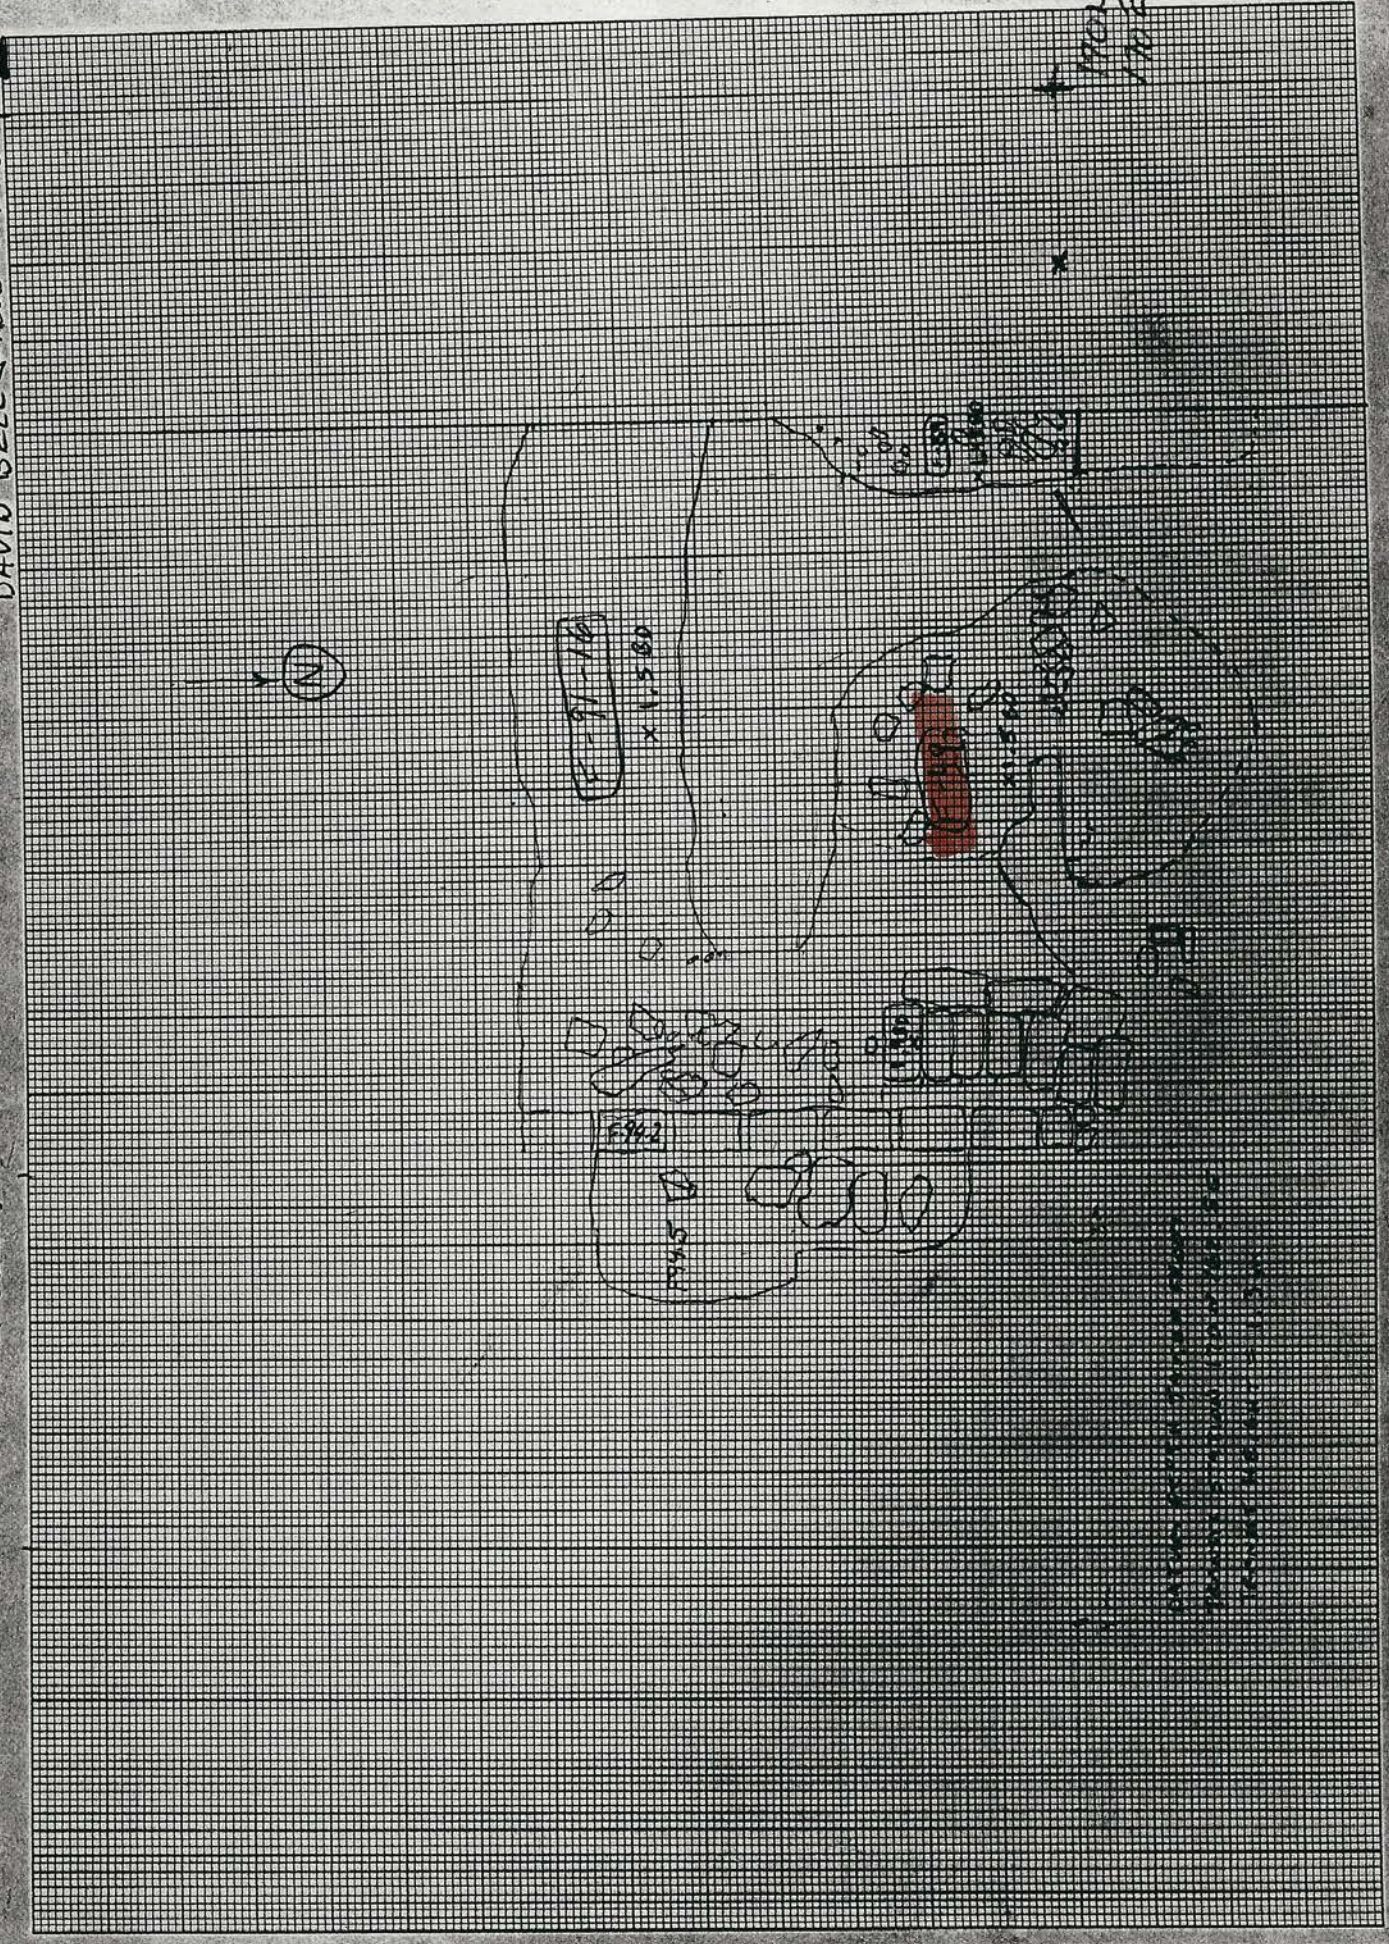
PLAN MAP OF RANDOLPH KITCHEN PORCH AREA (EAST)

Type of Feature "dog wallow" under E. porch of Randolph hitcher

small shallow pit chock full mortar, + broken bricks  
Northern half bisected in a previous yr. Could find no  
paper pertaining to this bisection.

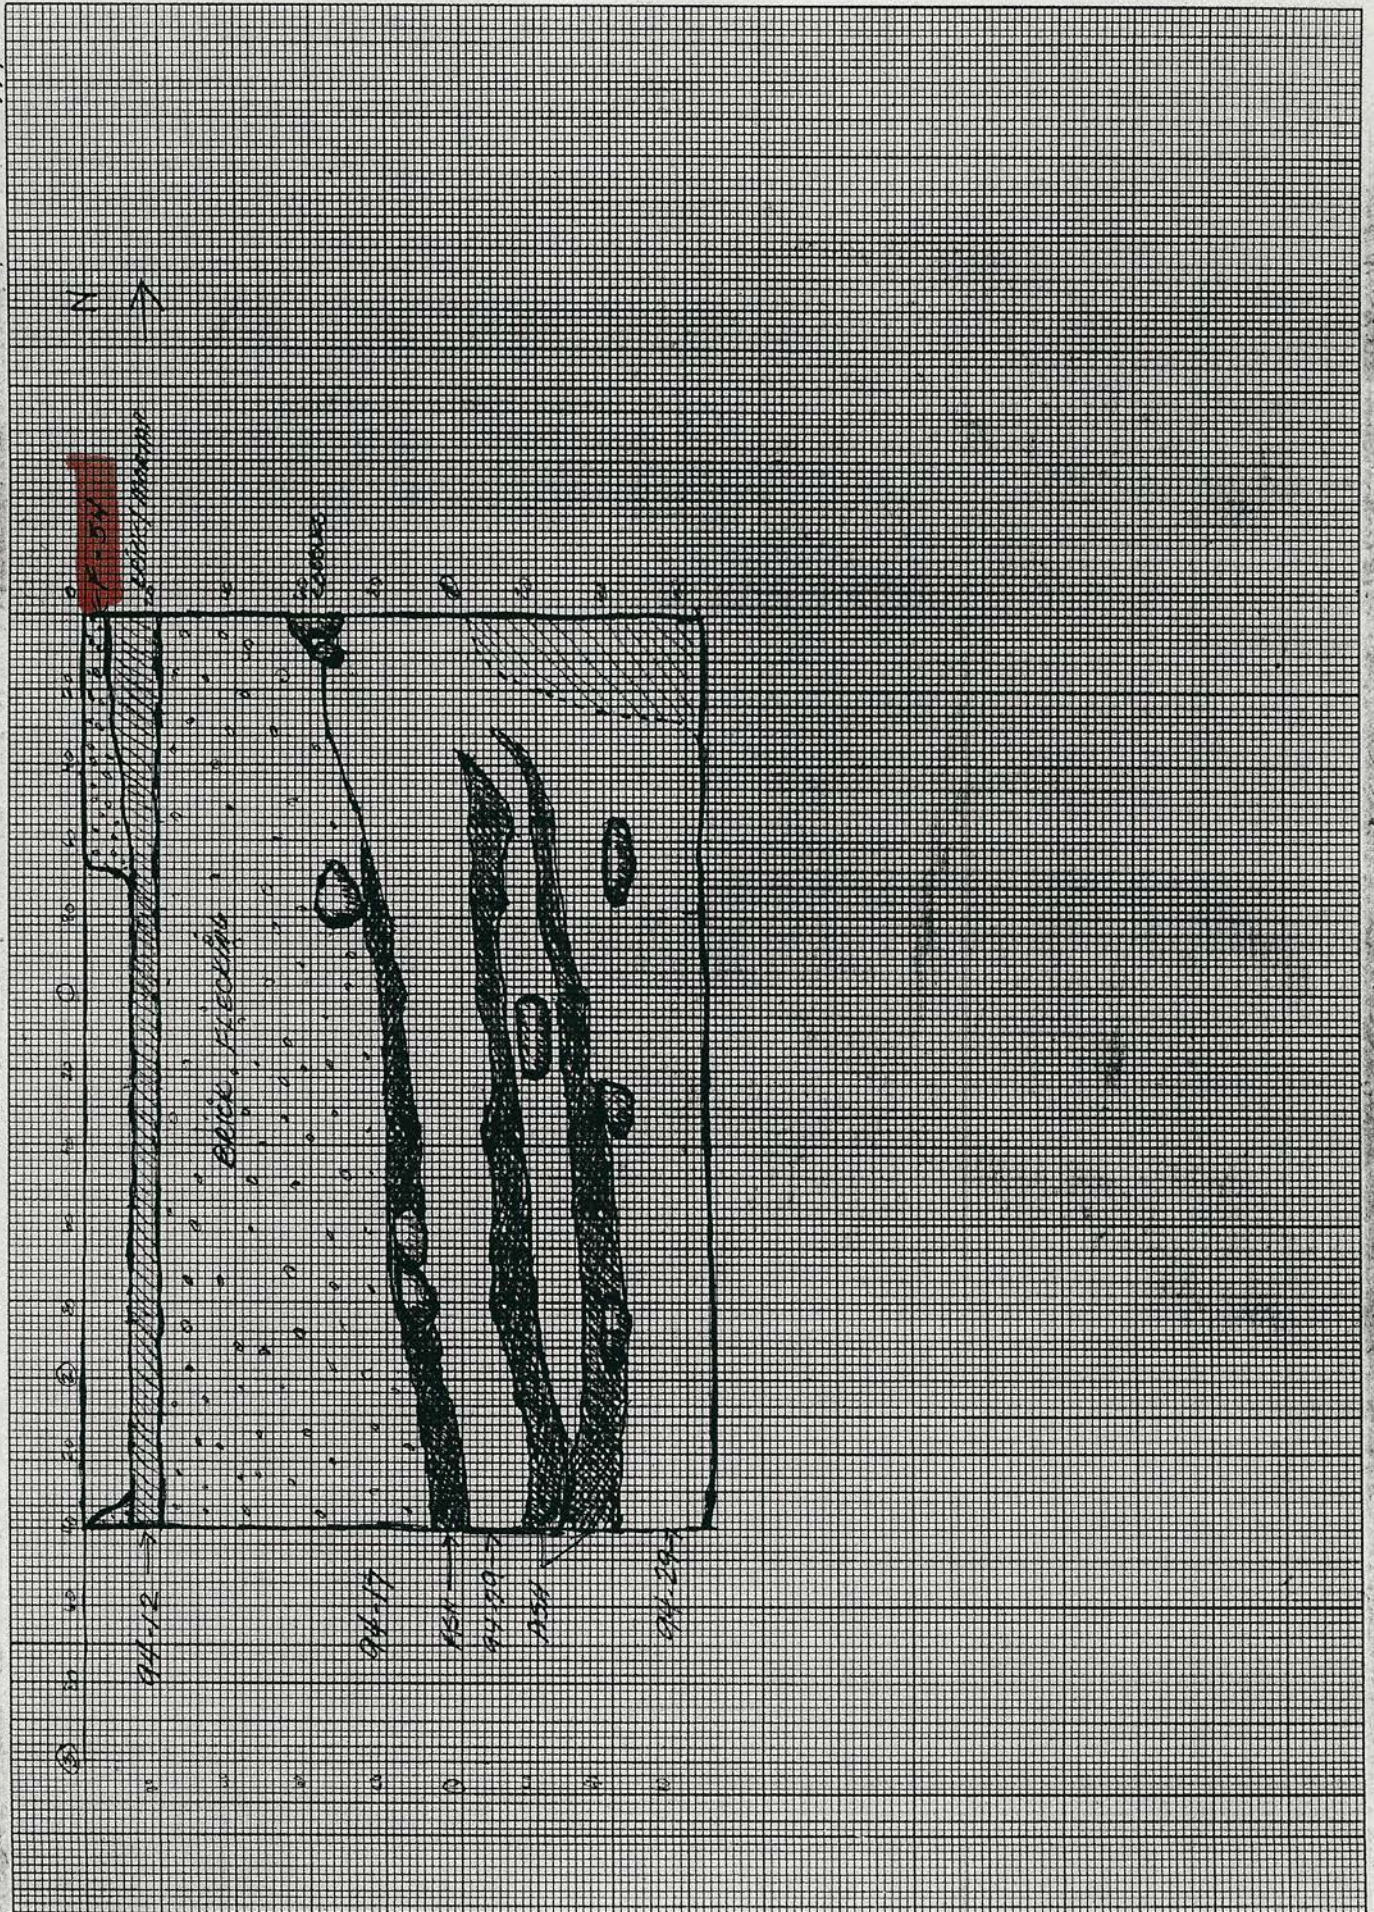
EAST PROFILE - BROWN'S TRENCH  
107.5 N - 160E

Cobble floor inside kitchen, main room.  
Removed from blocks 167.5 N 162.5 E,  
167.5 N 162.5 E. Concentrated cobbles &  
gravel in medium brown loam.
